AGRA  
MİMARLIK ve RESTORASYON

**EDİRNE PROVINCE, UZUNKÖPRÜ DISTRICT,  
MURADIYE MOSQUE NEIGHBORHOOD  
34 PLOT, BLOCK 97, PARCEL 6  
THE DWELLING (VICARAGE)  
PROJECT REPORT**

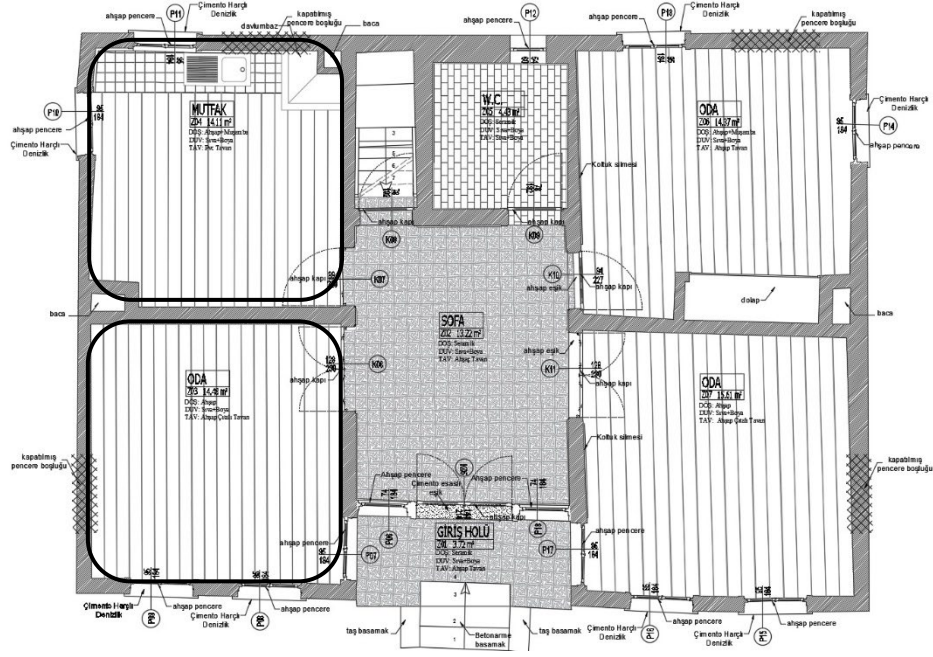
**Drawing 2: Ground Floor Plan**

The main door opens to the hall. There are rooms, kitchen and wc connected to this hall. The room indicated at the bottom left in the drawing has three windows. One of these windows faces the entrance hall and the others face the street. A window on the left facade has also been closed. These windows were changed during the renovations of the building over time and lost their originality. Wood was used as ceiling and flooring and the floors have not lost their originality. The door to the room has two wings and has not lost its originality. The area is 14.48m<sup>2</sup>.

The room indicated on the upper left in the drawing is used as a kitchen today. There is a countertop and hood in the room. The windows of the room have been changed due to the renovations of the building and there are two windows, one on the left and one on the rear facade. A window with a hood on the rear facade has been closed. The floor covering has not lost its originality but the ceiling covering has been replaced with PVC flooring. The door of the room is original and consists of a single wing and there is no door handle. The area is 14.11m<sup>2</sup>.

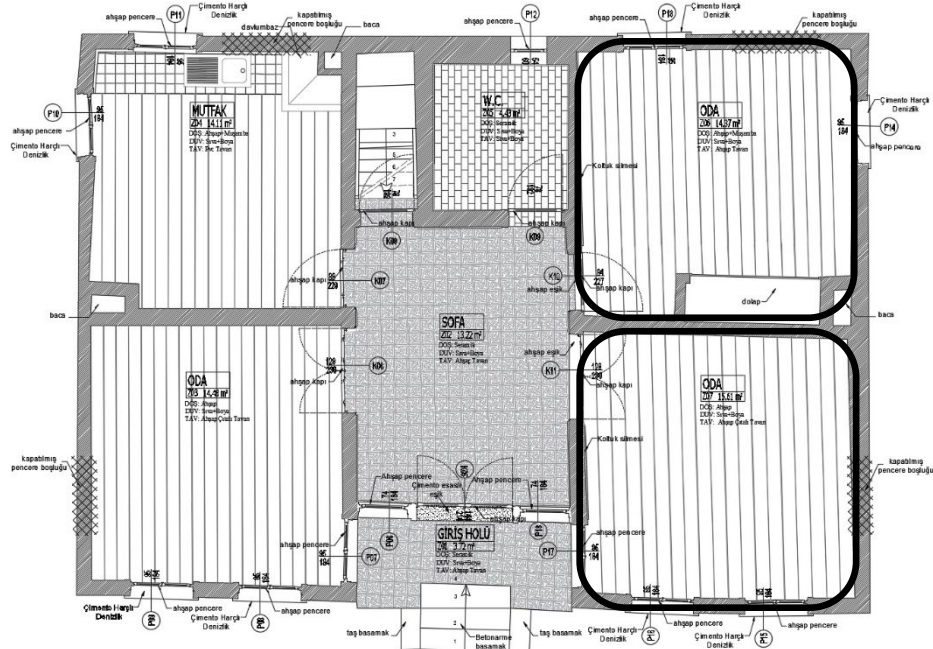
**Drawing 2: Ground Floor Plan**

There is a built-in closet in the room in the upper right corner indicated in the drawing. The room windows are the same as the windows in the other rooms. One window on the rear facade has been closed and there are two windows, one on the rear facade and one on the right facade. The floor covering preserves its originality. It is seen that the ceiling tile was replaced with wooden joinery during the renovations of the building in the past. The door of the room was changed during the renovation and there is an invented door. The area is 14.37m<sup>2</sup>.

The room indicated at the bottom right in the drawing has three windows. One of these windows faces the entrance hall and the others the street. A window on the right facade has also been closed. These windows were changed during the renovations of the building over time and lost their originality. The ceiling and floor coverings are made of wood and have not lost their originality. The door to the room has two wings and has not lost its originality. The area is 15.61m<sup>2</sup>.

Sofa provides distribution to the rooms, wc and basement floor. The flooring is currently ceramic tiles, but during the renovations of the building, it was seen that it was flooring on wooden beams and it

was changed in the restitution. The ceiling is wooden and quite simple and is generally in good condition. The area is 13.22m<sup>2</sup>.

The area currently used as a wc was found to have been used as a cargo hold in the past and was changed accordingly in the restitution. Ceramic tiles were used as flooring. Reinforced concrete was used as ceiling slab. There is a built-in door and window. The area is 4.43m<sup>2</sup>.

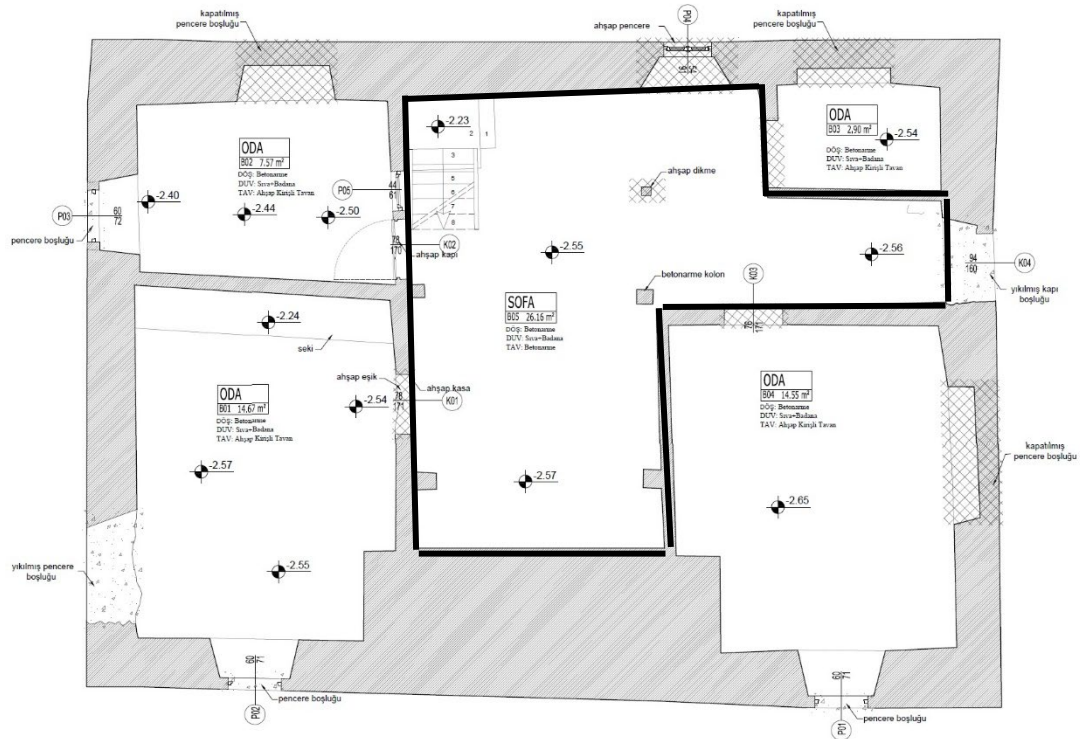
**Drawing 3: Basement Floor Plan**

The sofa provides distribution to the rooms and the garden as indicated in the drawing. Its floor is reinforced concrete and has not lost its originality. The ceiling was replaced with reinforced concrete during the renovation when it should have been wooden beams on wooden beams. This can be clearly

understood both from the beams and girders in the hall and when compared to the other rooms. The connection between the ground floor and the basement is provided from here and this connection is made by a staircase with 8 steps. The steps of this staircase are deformed and the 4th and 6th steps are missing. The door opening to the garden has been demolished. The area is 26.16m<sup>2</sup>.

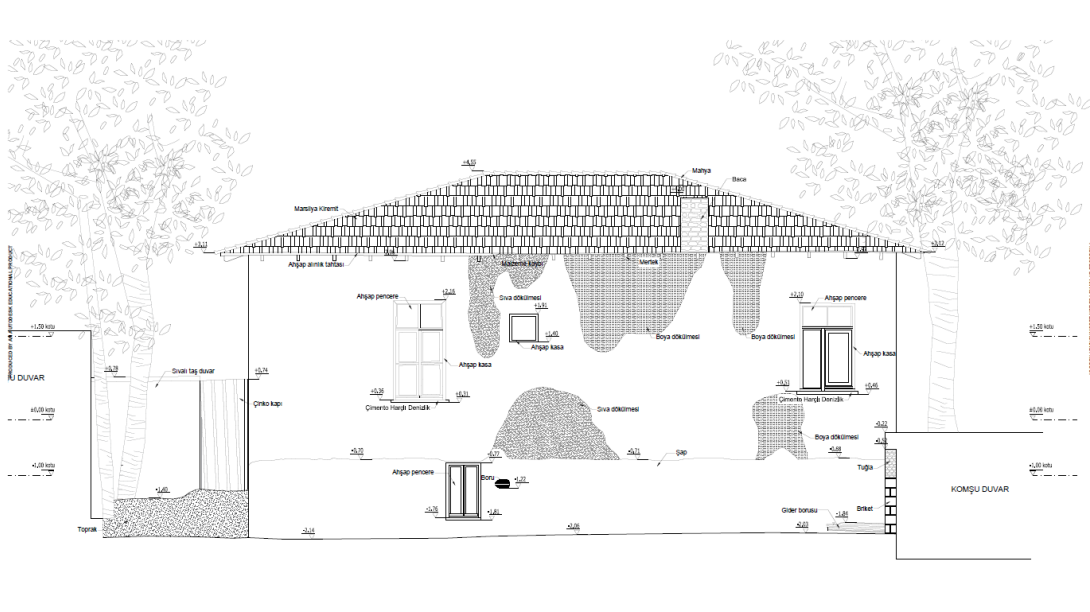
**Illustration 6: Rear Facade**

There are four windows on the rear facade of the building, including the wc ventilation window, but four windows have been closed on this facade. One of these closed windows is in the room used as a kitchen on the ground floor, the other one is in the room directly opposite the kitchen and the remaining two are in the rooms facing the rear facade in the basement. The facade is generally in poor condition. Plaster, paint loss and plaster cracks are seen intensely. The height of the facade from the ground to the eaves is 511cm.

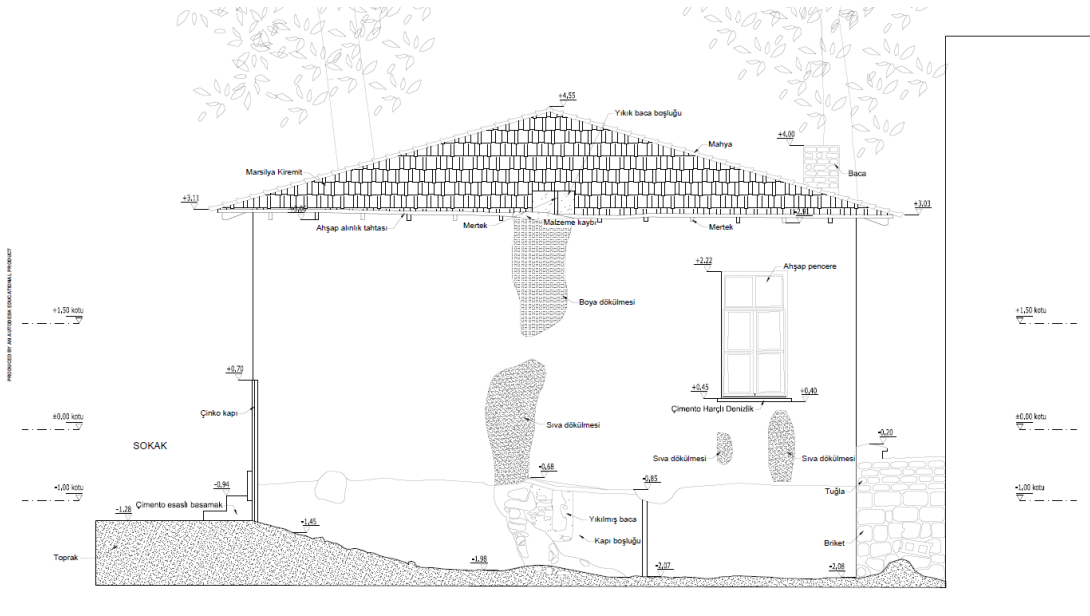
**Illustration 7: Right Facade**

There is currently a window and a door on the right facade of the building, but two windows have been closed. One of them is in the room facing the road on the ground floor and the other one is in the room facing the road on the basement floor. The door on this facade establishes the connection between the building and the garden. This door is in ruins and in poor condition. The facade is generally in poor condition. There are plaster paint spills and plaster cracks. There are also collapses on the building wall. The height of the building up to the eaves is variable and varies between a minimum of 434cm and a maximum of 508cm.
