**EDİRNE PROVINCE,  
UZUNKÖPRÜ DISTRICT,  
MURADIYE CAMİ  
NEIGHBORHOOD, 34 PLAN, 97  
ISLAND, 6 PARCEL**

## **LOCATED IN THE DWELLING (RECTORY)**

### **REPORT DATED 22.11.2018**

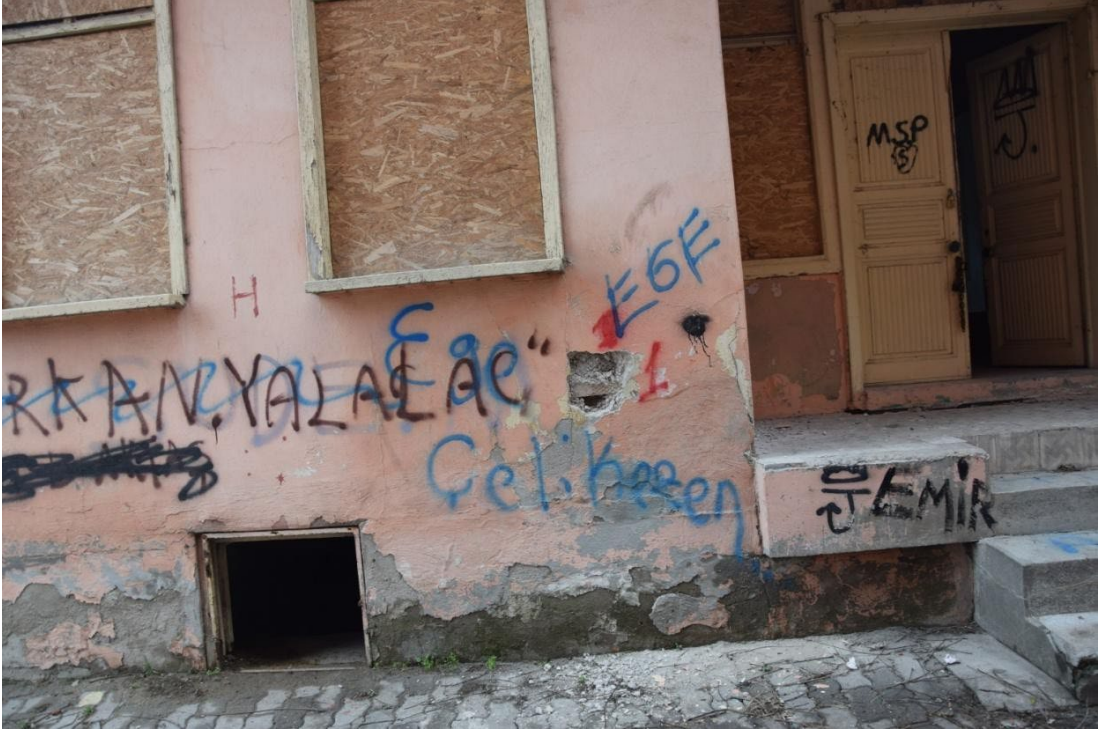
Photo 1

1 The scrape numbered scrape was made under the upper floor window on the front façade of the building. (Drawing 1, F.1) It is a scrape measuring approximately 25x25 cm. This scraping was carried out in search of wood veneer. Firstly, traces of cement plaster were found. Metal mesh was exposed under the cement plaster. Then the wooden carcass and filling material of the building was reached.(F.2)

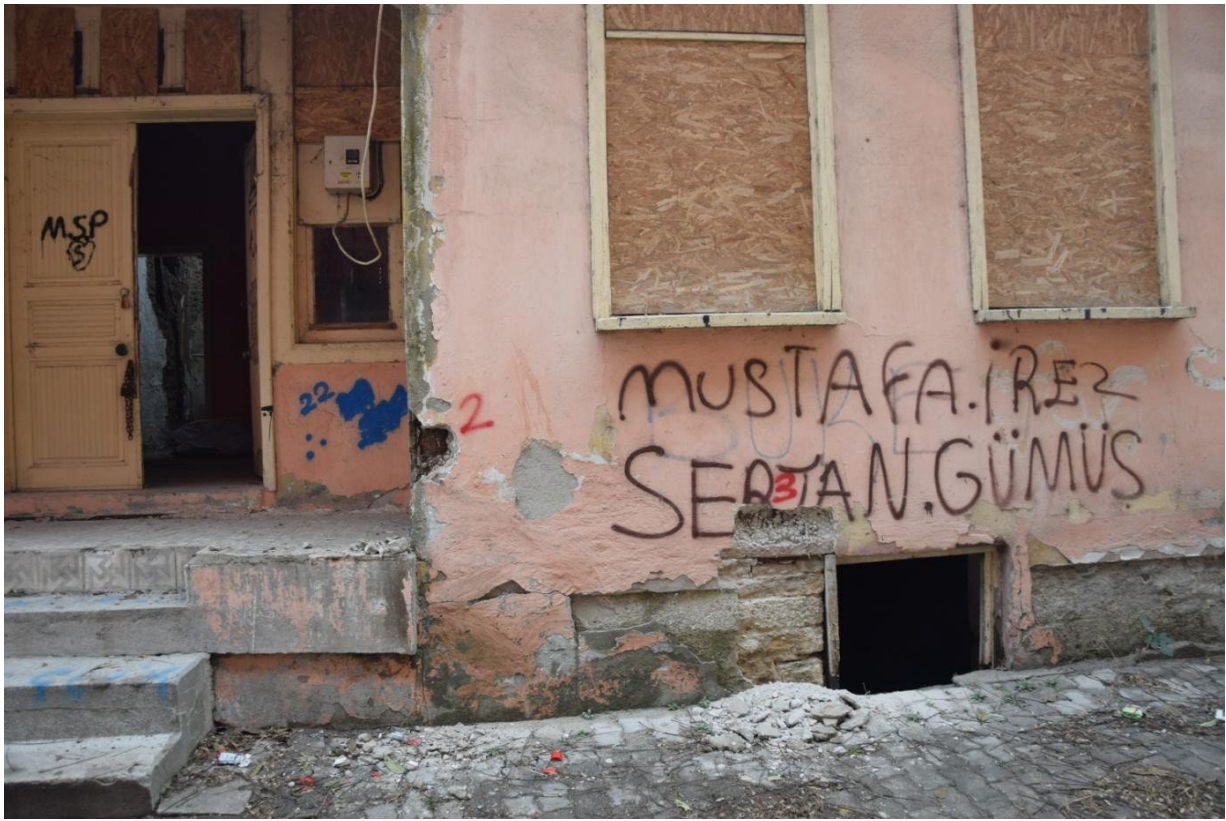
Photo 3

2 The scrape numbered scrape is located on the front façade of the building to the right of the entrance.(Drawing 1,F.3) It is a scrape measuring approximately 20x20 cm. Firstly, cement plaster and metal mesh were found. Then the wooden pillar of the structure was revealed. There are nails on the wooden pillar. This scraping was carried out in search of wooden cladding. No wooden cladding was found (F.4)

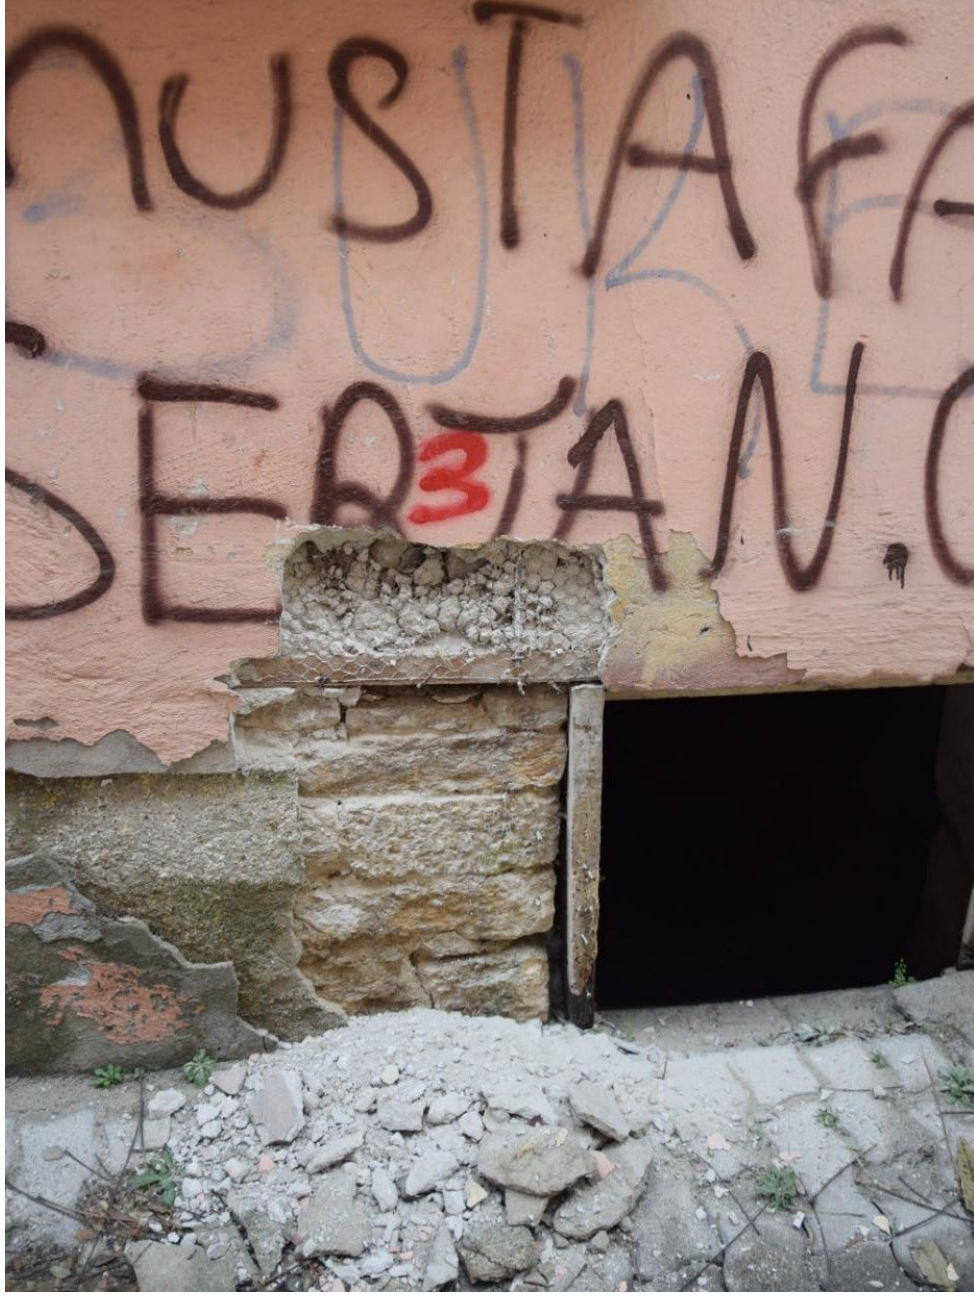
Photo 5

3 The scrape numbered scrape is located on the front façade of the building to the right of the entrance.(Drawing 1,F.5) It is a scrape measuring approximately 40x80 cm. Above the floor trace, wooden structure and filling were found in the part covered with cement plaster and metal mesh. A rubble stone wall was found in the basement. For this reason, stone texture was shown on the facade in the restitution study. As a result of this scraping, the stone texture was supported by traces from the building. (F.5)

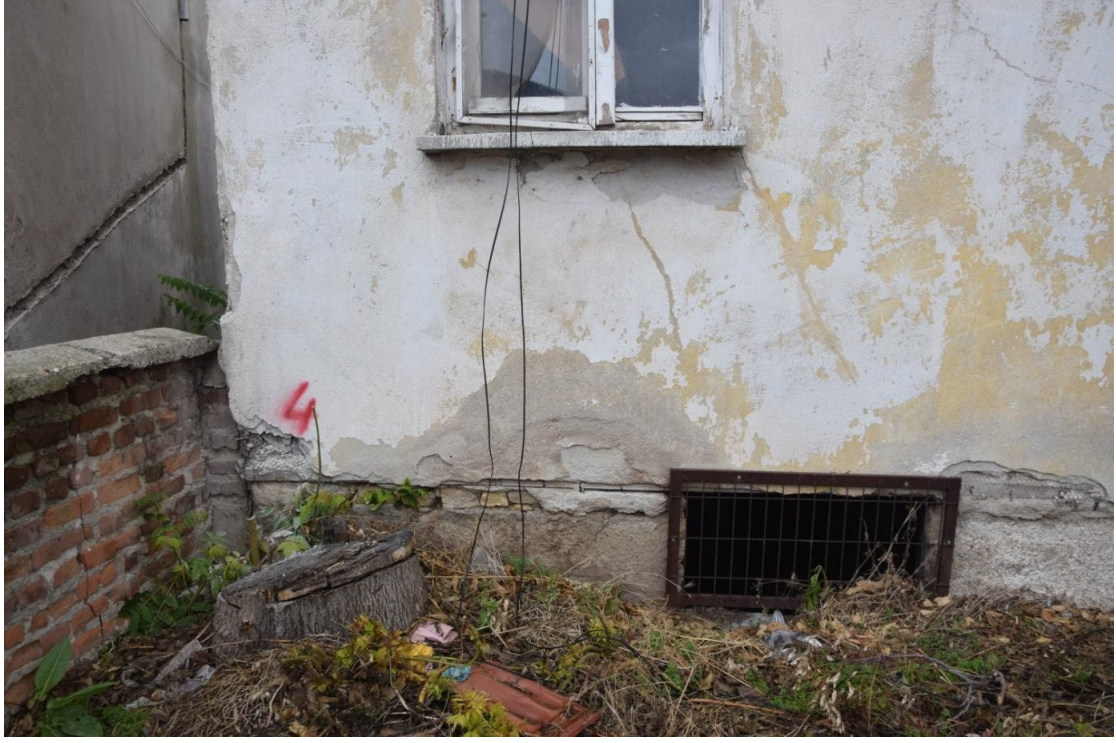
Photo 6

4 The scrape numbered scrape is located on the left side façade of the building.(Drawing 2, F.6) It is a scrape measuring approximately 30x20 cm. Above the floor trace, wooden structure and filling were found in the part covered with cement plaster and metal mesh. A rubble stone wall is visible in the basement. (F.7)

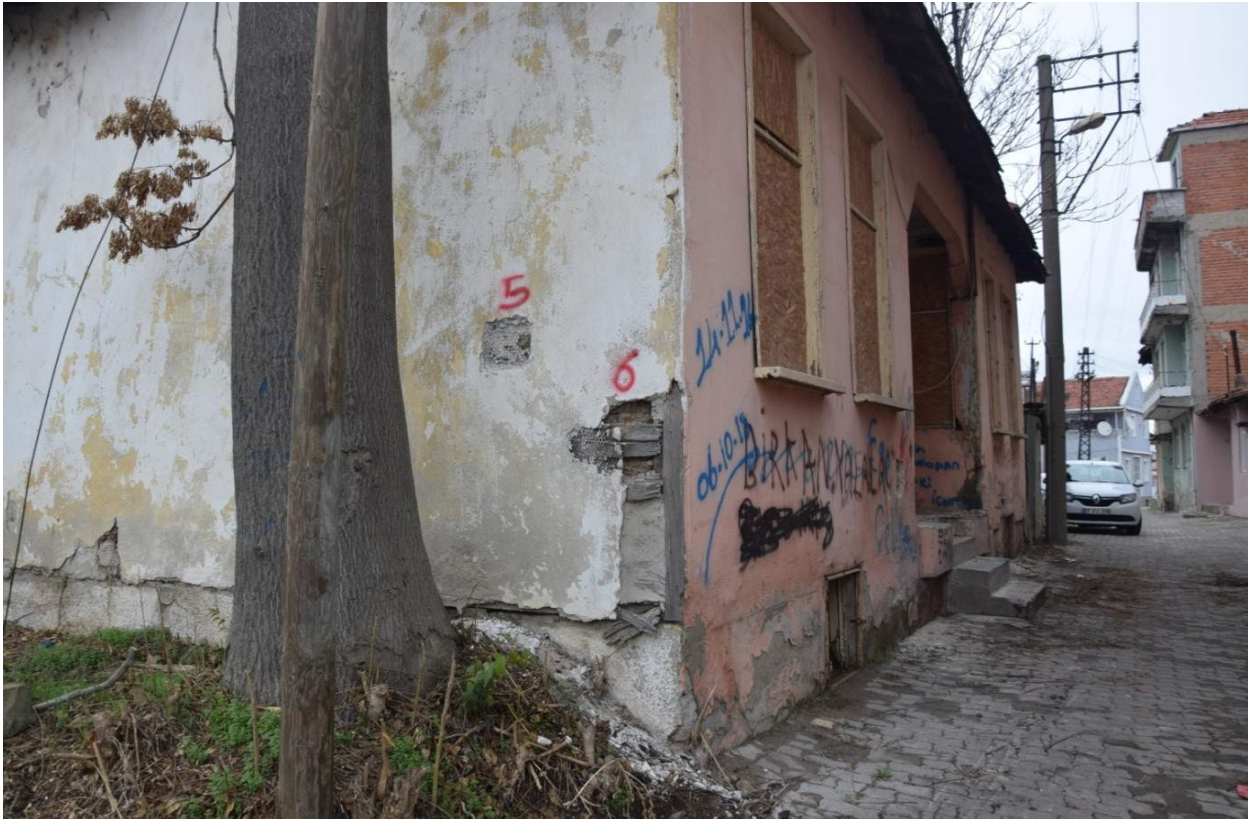
Photo 8

5 The scrape numbered scrape is located on the left side façade of the building.(Drawing 2, F.8) It is a scrape measuring approximately 25x20 cm. Above the floor trace, a filling between the wooden carcass was found in the section covered with cement plaster and metal mesh. (F.9) This scrape was opened in order to find a window trace. However, no trace was found.

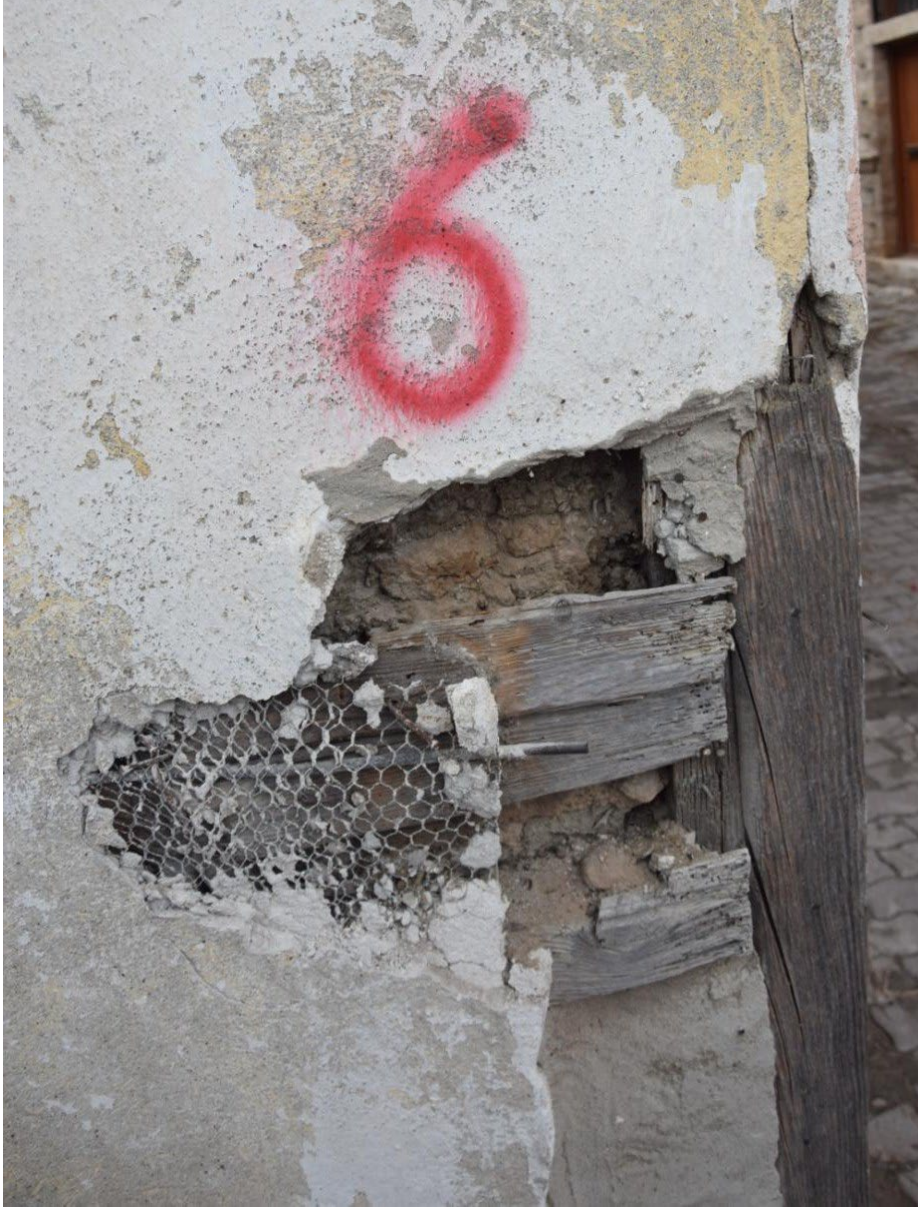
Photo 10

6 The scrape numbered scrape is located on the left side façade of the building.(Drawing 2, F.8) It is a scrape measuring approximately 40x40 cm. Above the floor trace, in the section covered with cement plaster and metal mesh, filling between the wooden carcass was found. This scraping was carried out in order to reach the wooden cladding. Three pieces of cladding were found above the floor trace. (F.10) These claddings are similar to the details of the claddings above the windows at the entrance. The wooden coverings shown on the façade in the restitution study were identified in this detail.

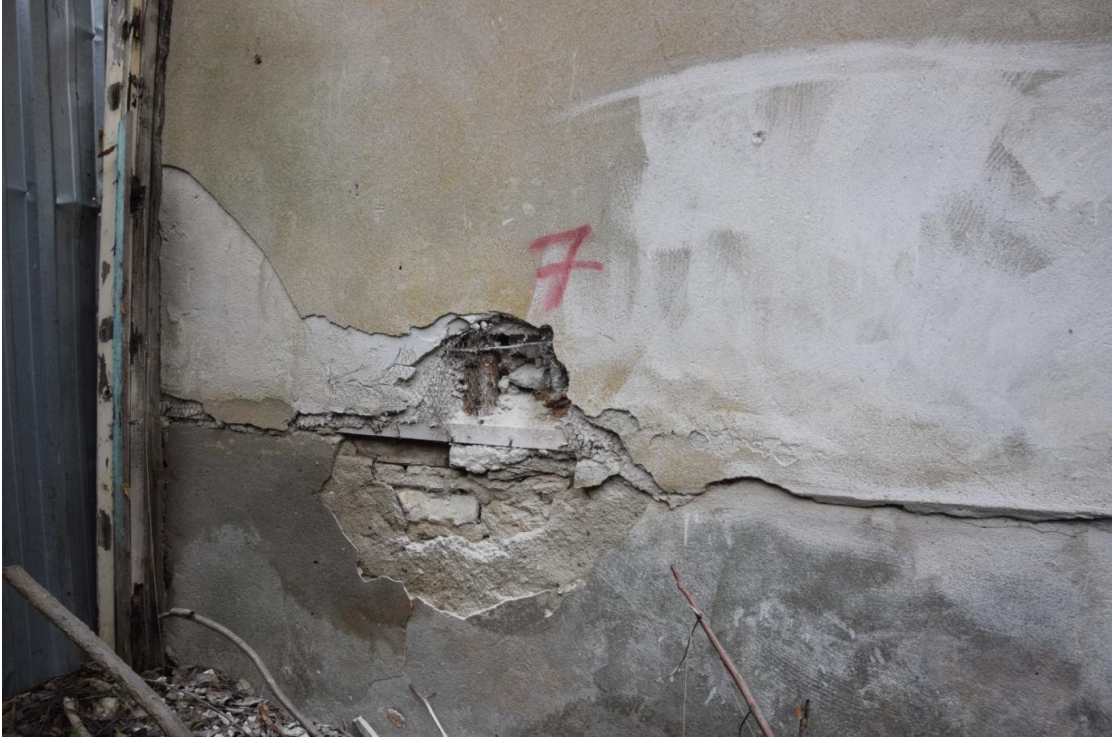
Photo 11

7 The scrape numbered scrape is located on the right side façade of the building.(Drawing 3, F.11) It is a scrape measuring approximately 30x20 cm. Above the floor trace, wooden carcass and filling were found in the section covered with cement plaster and metal mesh. This scraping was done in order to reach the wooden cladding. There is no wooden cladding.(F.12)

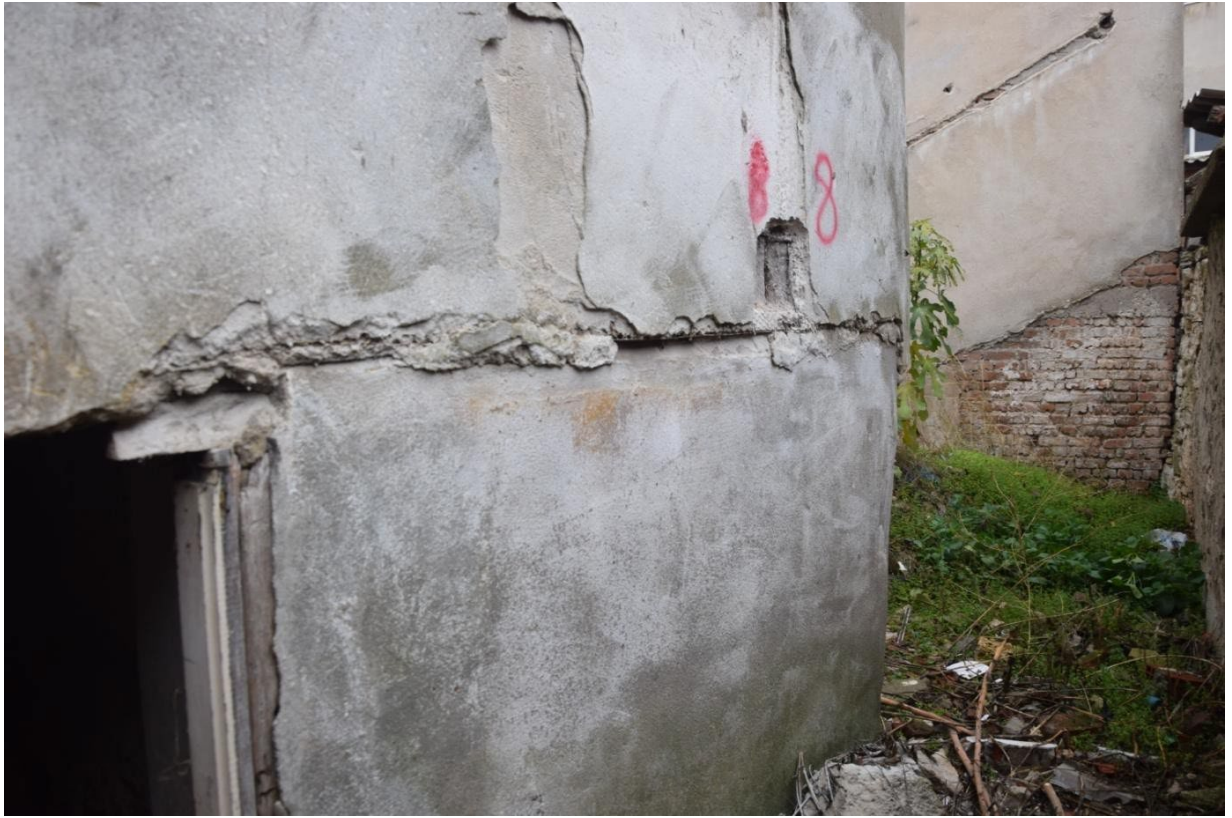
Photo 13

8 The scrape numbered scrape is located on the right side façade of the building.(Drawing 3, F.13) It is a scrape measuring approximately 30x25 cm. Above the floor trace, wooden carcass and filling were found in the section covered with cement plaster and metal mesh. This scraping was done in order to reach the wooden cladding. There is no wooden cladding. However, there are plenty of nails on the wooden carcass.(F.14)

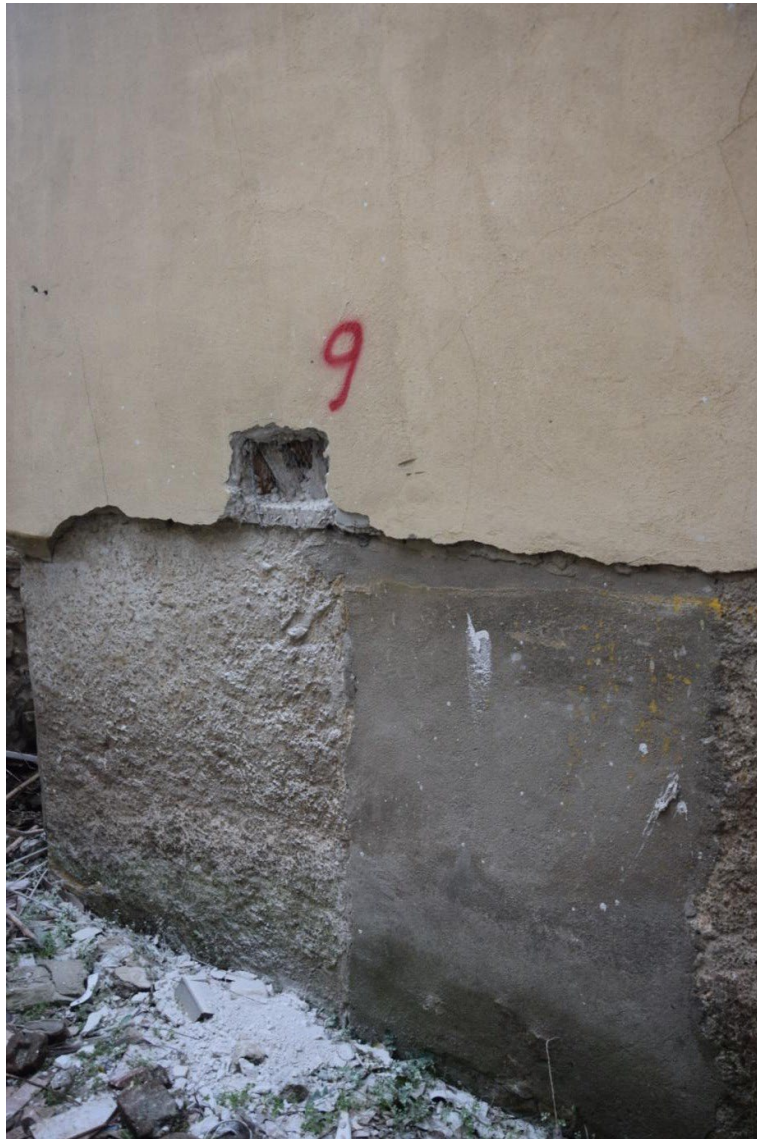
Photo 15

9 (Drawing 4, F.15) It is a scrape measuring approximately 30x20 cm. Above the floor trace, wooden carcass and filling were found in the section covered with cement plaster and metal mesh. This scraping was done in order to reach the wooden cladding. There is no wooden cladding. However, there are plenty of nails on the wooden carcass.(F.16)

Photograph 15 also shows a window opening plastered with a different plaster. This part was covered with bricks inside and no plaster was applied on the bricks. Therefore, it was not necessary to scrape to reach the window.(F.15)

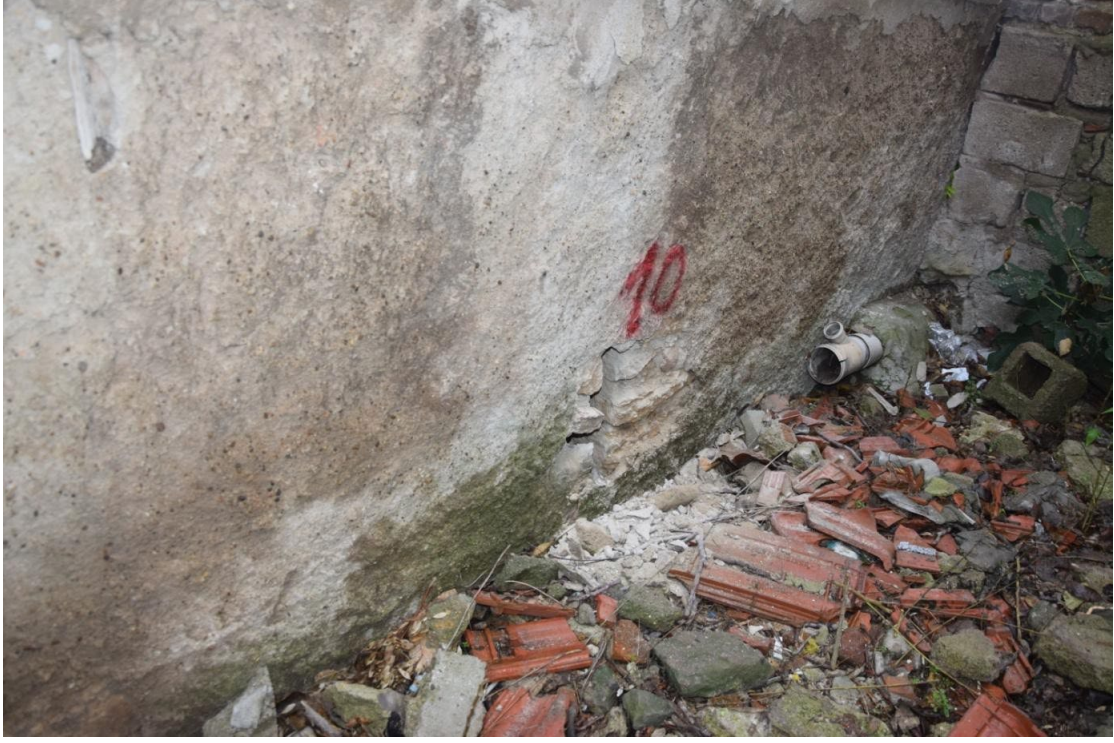
Photo 17

10 The scrape numbered scrape is located on the rear façade of the building.(Drawing 4, F.17) It is a scrape measuring approximately 40x35 cm. In fact, this area was filled with rubble stone on the inner wall of the building and the trace of the window is visible. The trace of the window cavity was also reached in the rasp number 10 on the outer wall.(F.18) At the same time, the stone texture given in the basement of the facade in the restitution and restoration studies was also reached as a result of this rasp.

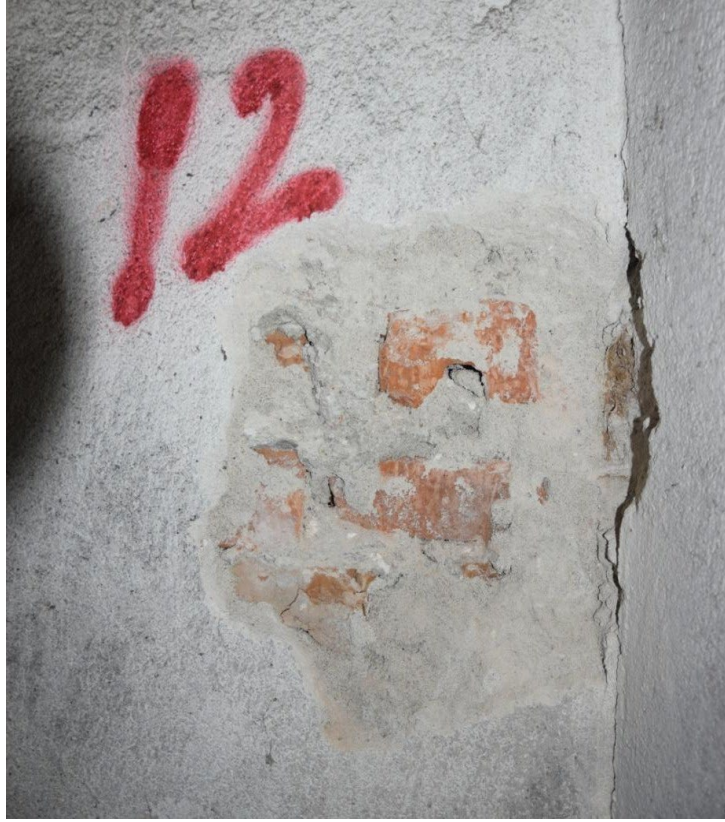
Photo 21

12 The numbered scrape was made near the right edge of the niche. It is a scrape measuring approximately 20x30 cm. No traces of a window were found here either. The bricks exposed after the cement plastering are the same as the bricks exposed in scraping number 11. (F.21)

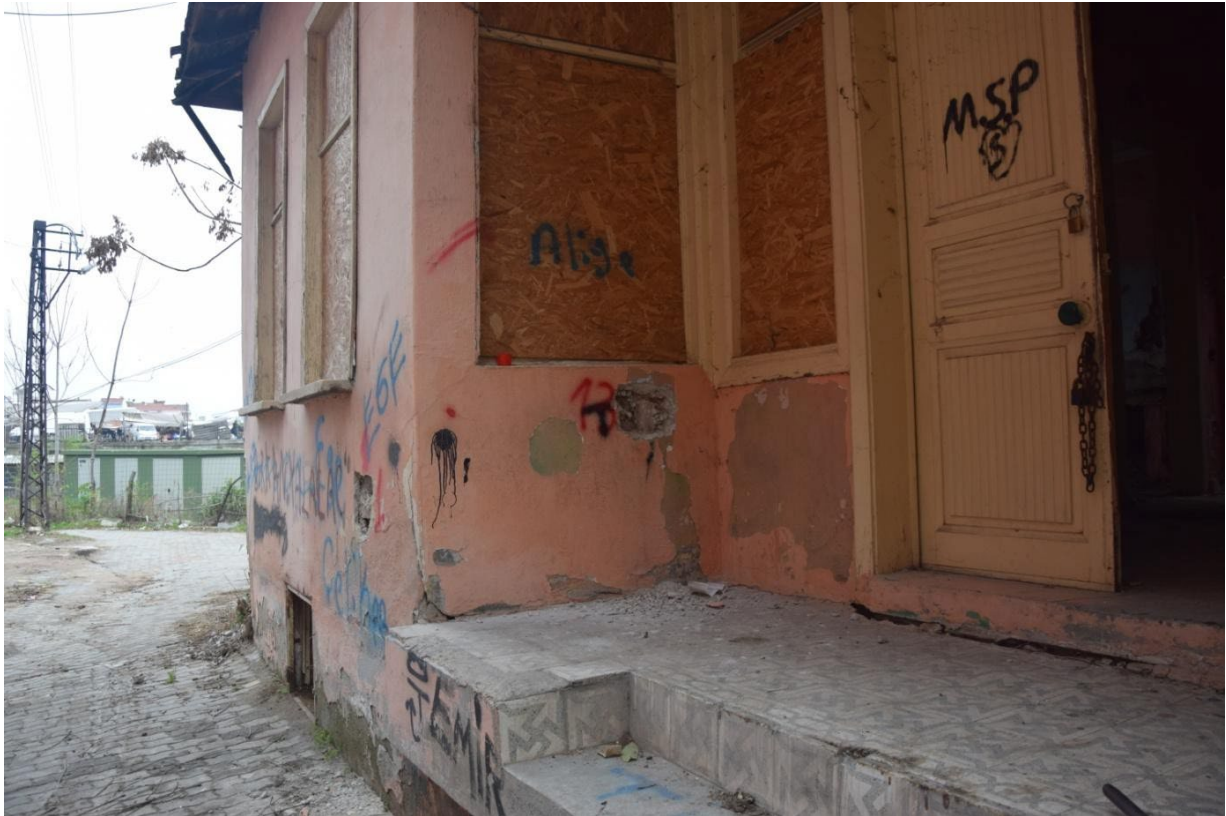
Photo 22

The scraping under the window to the left of the entrance hall was carried out in order to reach the traces of wooden cladding. (Drawing 6, F.22) It is a scraping measuring approximately 25x20 cm. In rasp number 13, when the cement plaster was removed, metal mesh and wood frame and filling were found. The wooden cladding could not be reached. (F.23)

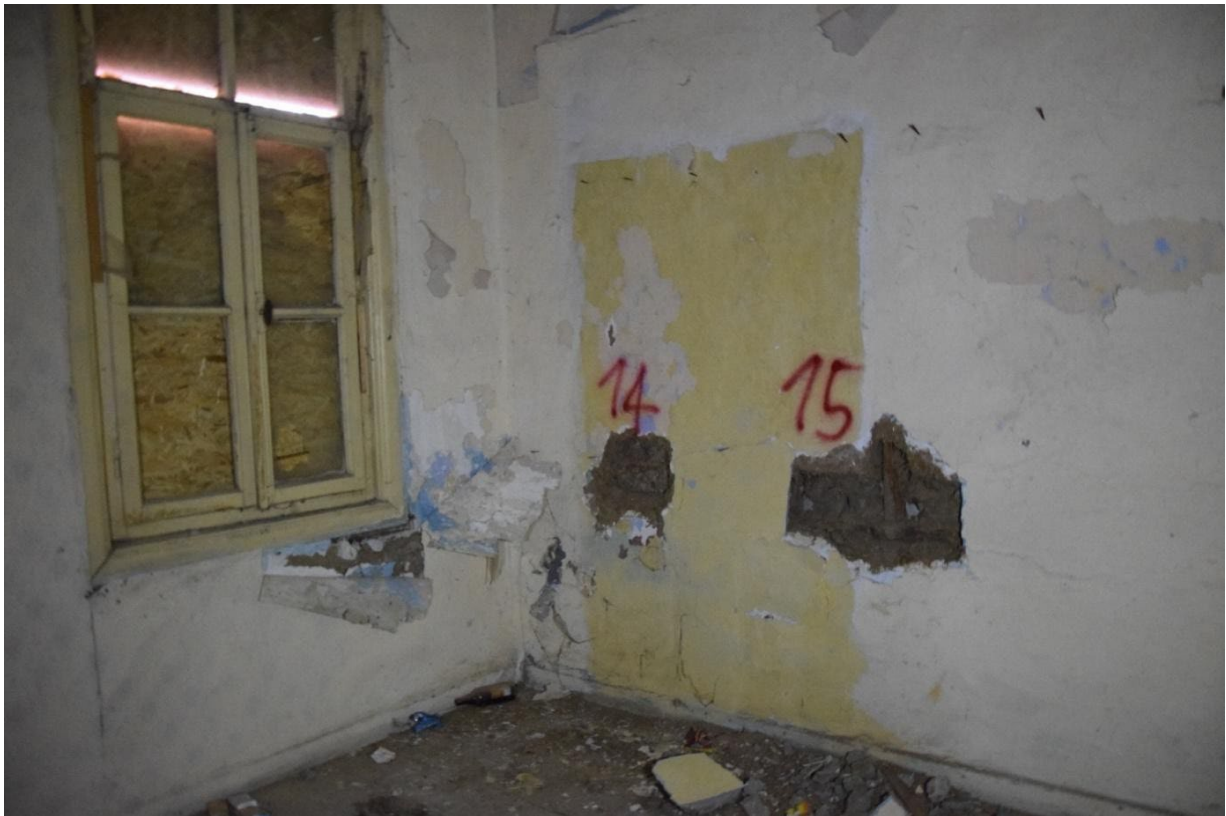
Photo 24

Rasps 14 and 15 in Room Z03 were opened in order to reach the window trace. (Drawing 7, F.24) The rasps first reached the mudbrick plaster. The presence of mudbrick plaster indicates that no intervention was made here. Nevertheless, the mudbrick plaster was partially removed. In rasp number 14, the mudbrick filling between the carcasses was reached. It is a scrape measuring approximately 30x30 cm. (F.25) In the scrape numbered 15, the wooden carcass and the mudbrick filling between it were reached. It is a scraper measuring approximately 50x30 cm. (F.26) As a result of these two scrapers, no traces of any windows were found.

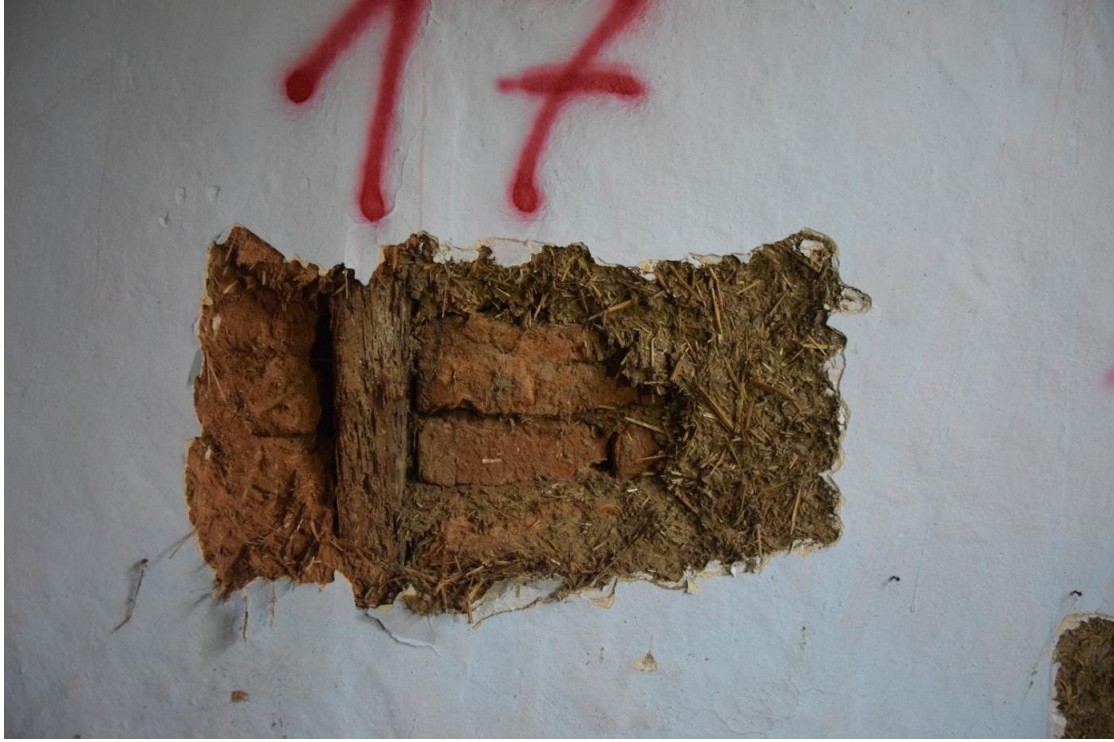
Photo 30

Rasps 17 and 18 in Room Z06 were opened in order to reach the window trace. (Drawing 8, F.29) In the rasp number 17, primarily adobe plaster was exposed. Beneath the mudbrick plaster, wooden frame and brick filling were found. It is a rasp measuring approximately 55x30 cm. (F.30) In the rasp numbered 18, mudbrick filling between mudbrick plaster and wooden carcass was encountered. It is a scraper measuring approximately 60x60 cm. (F.31) The presence of mudbrick plaster in the scrapers indicates that there is no subsequent closure here.

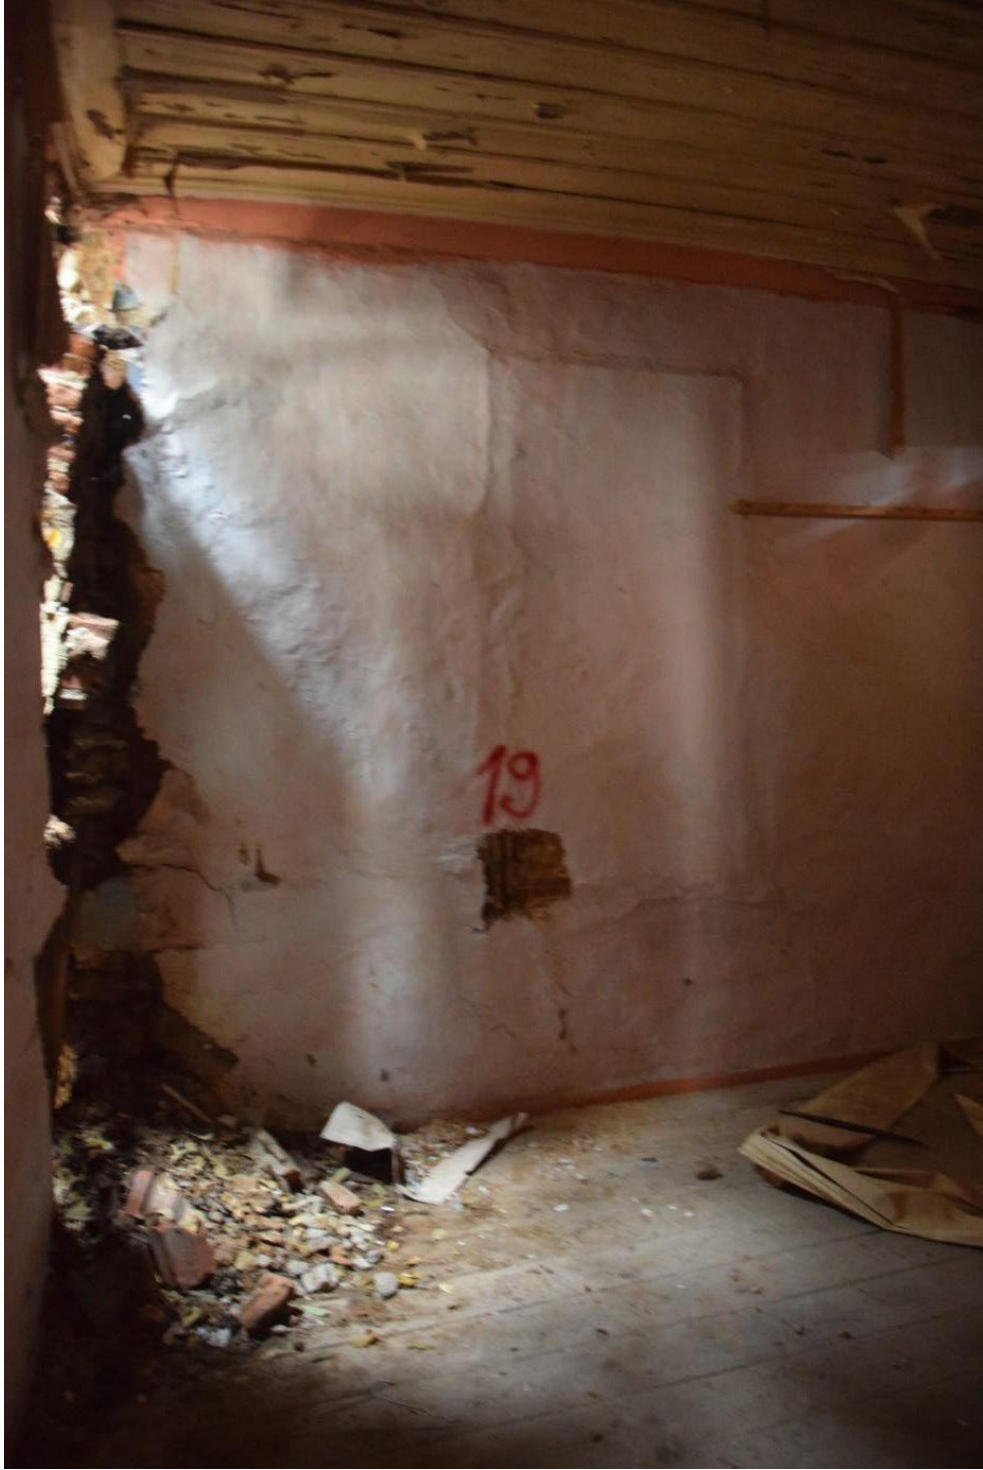
Photo 32

Scrape number 19 in Room Z07 was opened to reach the window trace. (Drawing 5, F.32) It is a scrape measuring approximately 30x30 cm. A window trace was found in the scrape opened here.(F.33) When we look at the whole, swelling in the plaster is observed along the window axis on the wall.
