AGRA  
MİMARLIK ve RESTORASYON

**EDİRNE PROVINCE, UZUNKÖPRÜ DISTRICT,  
MURADIYE MOSQUE NEIGHBORHOOD  
34 PLOT, BLOCK 97, PARCEL 6  
THE DWELLING (VICARAGE)  
PROJECT REPORT**

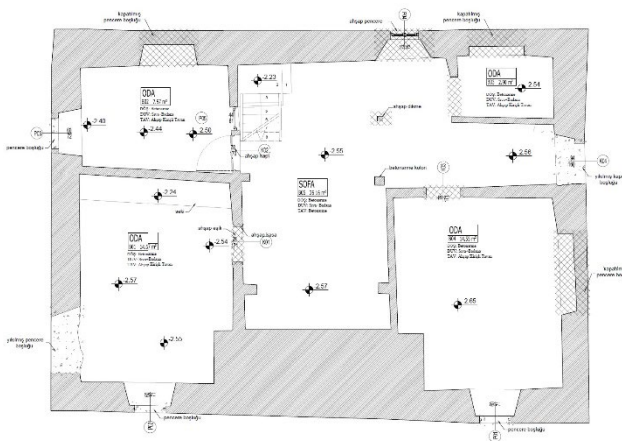
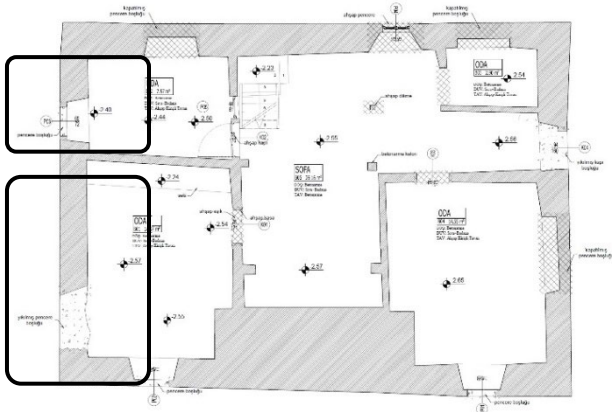
The sofa provides distribution to the rooms and the garden as indicated in the drawing. Its floor is reinforced concrete and has not lost its originality. The ceiling was replaced with reinforced concrete during the renovation when it should have been wooden beams on wooden beams. This can be clearly

understood both from the beams and girders in the hall and when compared to the other rooms. The connection between the ground floor and the basement is provided from here and this connection is made by a staircase with 8 steps. The steps of this staircase are deformed and the 4th and 6th steps are missing. The door opening to the garden has been demolished. The area is 26.16m<sup>2</sup>.
