**EDİRNE PROVINCE,  
UZUNKÖPRÜ DISTRICT,  
MURADIYE CAMİ  
NEIGHBORHOOD, 34 PLAN, 97  
ISLAND, 6 PARCEL**

## **LOCATED IN THE DWELLING (RECTORY)**

### **REPORT DATED 22.11.2018**

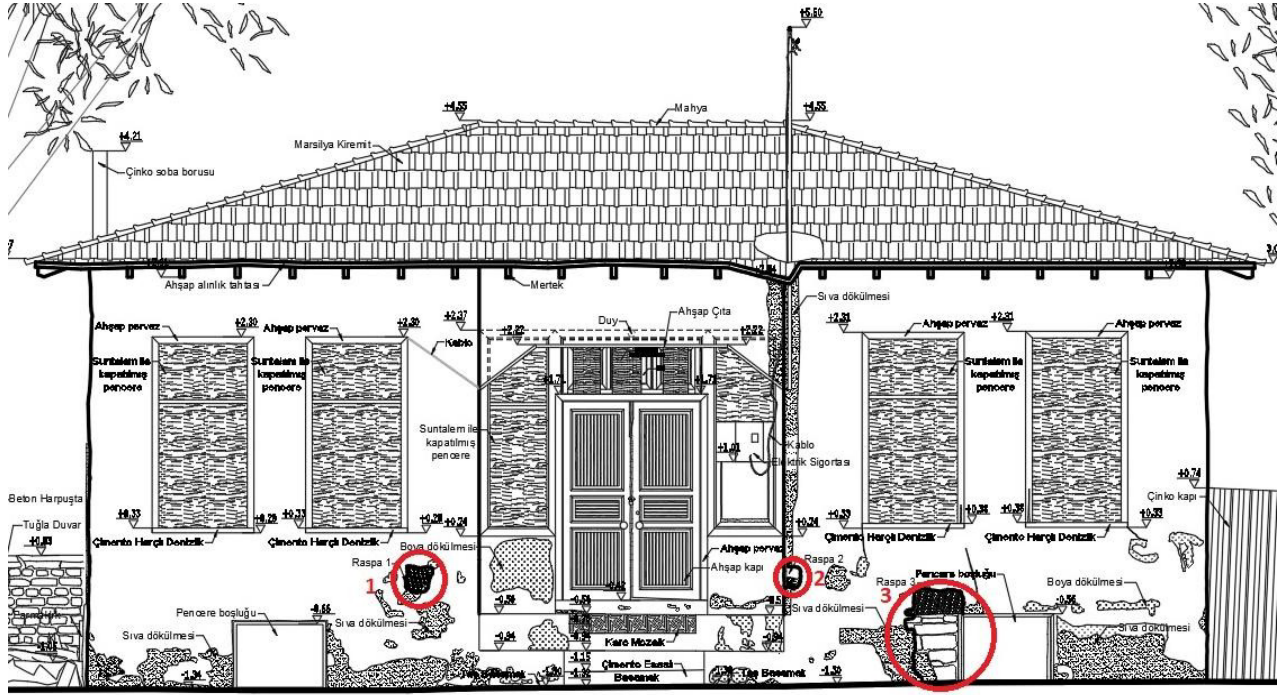
Drawing 1 - Front Facade

1 The scrape numbered scrape was made under the upper floor window on the front façade of the building. (Drawing 1, F.1) It is a scrape measuring approximately 25x25 cm. This scraping was carried out in search of wood veneer. Firstly, traces of cement plaster were found. Metal mesh was exposed under the cement plaster. Then the wooden carcass and filling material of the building was reached.(F.2)

2 The scrape numbered scrape is located on the front façade of the building to the right of the entrance.(Drawing 1,F.3) It is a scrape measuring approximately 20x20 cm. Firstly, cement plaster and metal mesh were found. Then the wooden pillar of the structure was revealed. There are nails on the wooden pillar. This scraping was carried out in search of wooden cladding. No wooden cladding was found (F.4)

3 The scrape numbered scrape is located on the front façade of the building to the right of the entrance.(Drawing 1,F.5) It is a scrape measuring approximately 40x80 cm. Above the floor trace, wooden structure and filling were found in the part covered with cement plaster and metal mesh. A rubble stone wall was found in the basement. For this reason, stone texture was shown on the facade in the restitution study. As a result of this scraping, the stone texture was supported by traces from the building. (F.5)

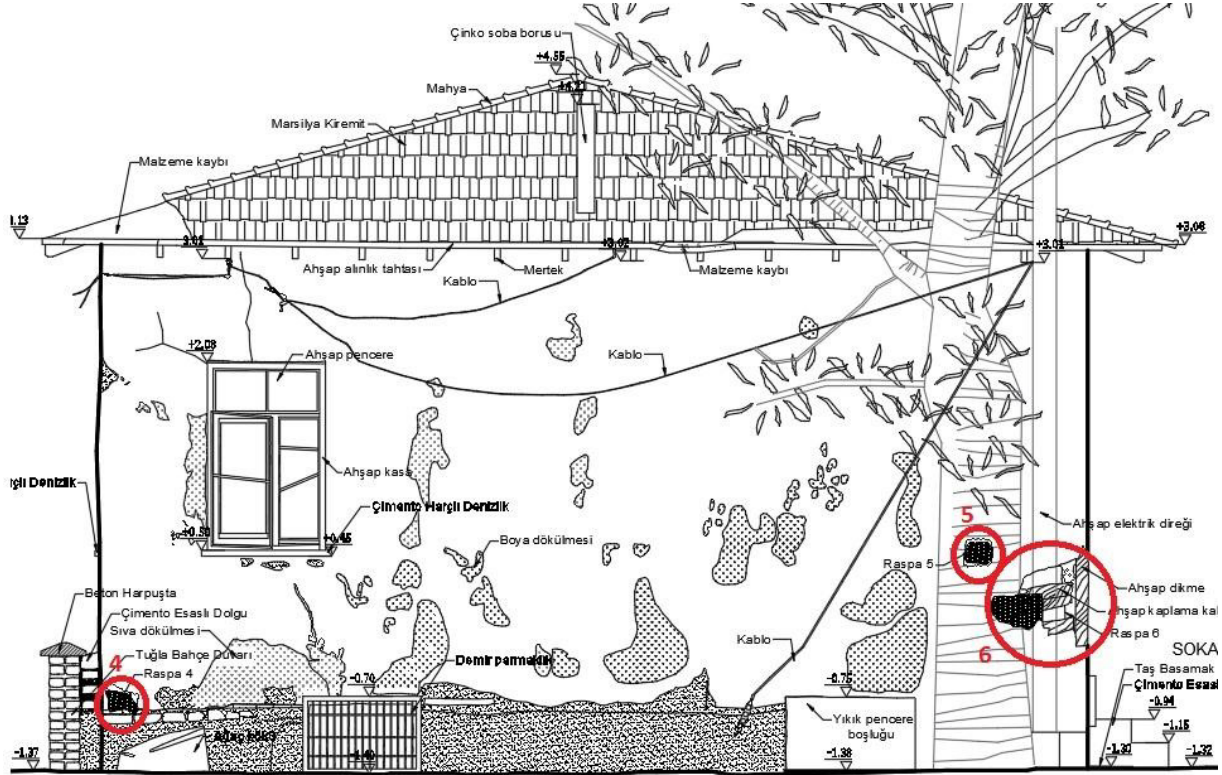
Illustration 2 - Left Side Facade

4 The scrape numbered scrape is located on the left side façade of the building.(Drawing 2, F.6) It is a scrape measuring approximately 30x20 cm. Above the floor trace, wooden structure and filling were found in the part covered with cement plaster and metal mesh. A rubble stone wall is visible in the basement. (F.7)

5 The scrape numbered scrape is located on the left side façade of the building.(Drawing 2, F.8) It is a scrape measuring approximately 25x20 cm. Above the floor trace, a filling between the wooden carcass was found in the section covered with cement plaster and metal mesh. (F.9) This scrape was opened in order to find a window trace. However, no trace was found.

6 The scrape numbered scrape is located on the left side façade of the building.(Drawing 2, F.8) It is a scrape measuring approximately 40x40 cm. Above the floor trace, in the section covered with cement plaster and metal mesh, filling between the wooden carcass was found. This scraping was carried out in order to reach the wooden cladding. Three pieces of cladding were found above the floor trace. (F.10) These claddings are similar to the details of the claddings above the windows at the entrance. The wooden coverings shown on the façade in the restitution study were identified in this detail.

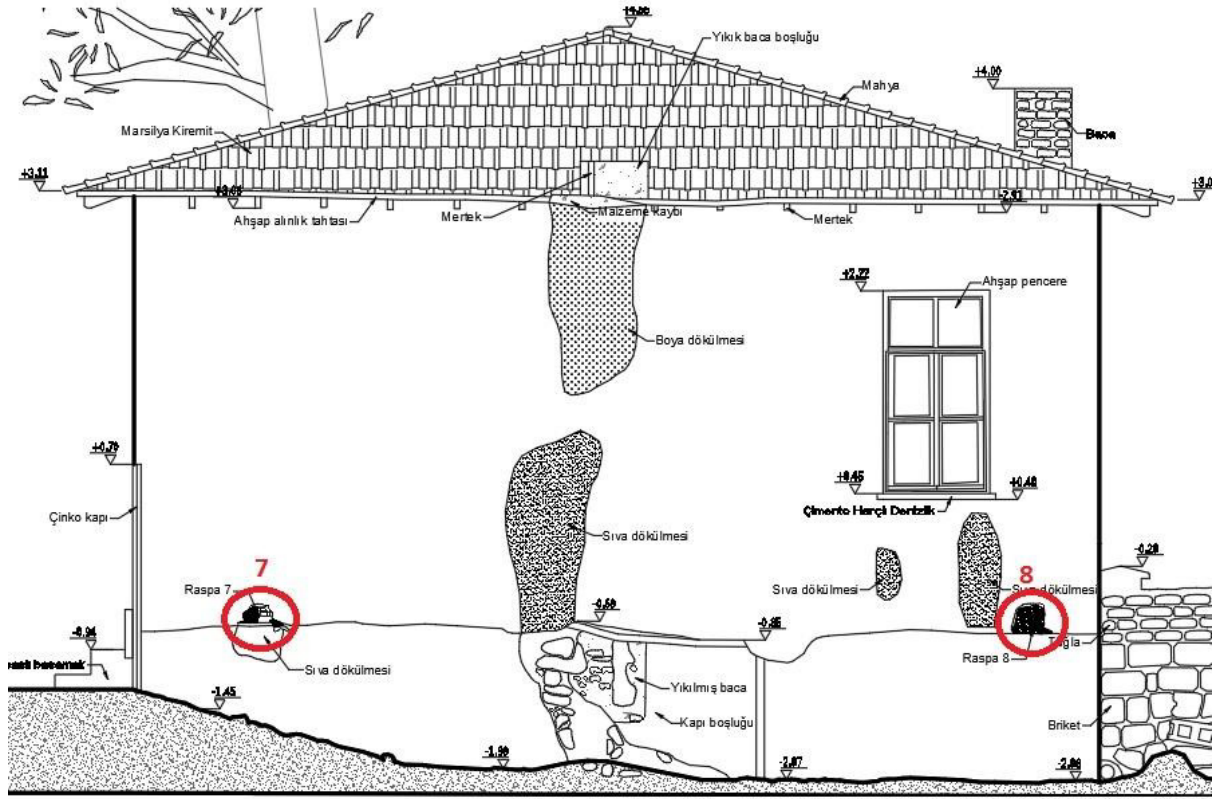
Illustration 3 - Right Side Facade

7 The scrape numbered scrape is located on the right side façade of the building.(Drawing 3, F.11) It is a scrape measuring approximately 30x20 cm. Above the floor trace, wooden carcass and filling were found in the section covered with cement plaster and metal mesh. This scraping was done in order to reach the wooden cladding. There is no wooden cladding.(F.12)

8 The scrape numbered scrape is located on the right side façade of the building.(Drawing 3, F.13) It is a scrape measuring approximately 30x25 cm. Above the floor trace, wooden carcass and filling were found in the section covered with cement plaster and metal mesh. This scraping was done in order to reach the wooden cladding. There is no wooden cladding. However, there are plenty of nails on the wooden carcass.(F.14)

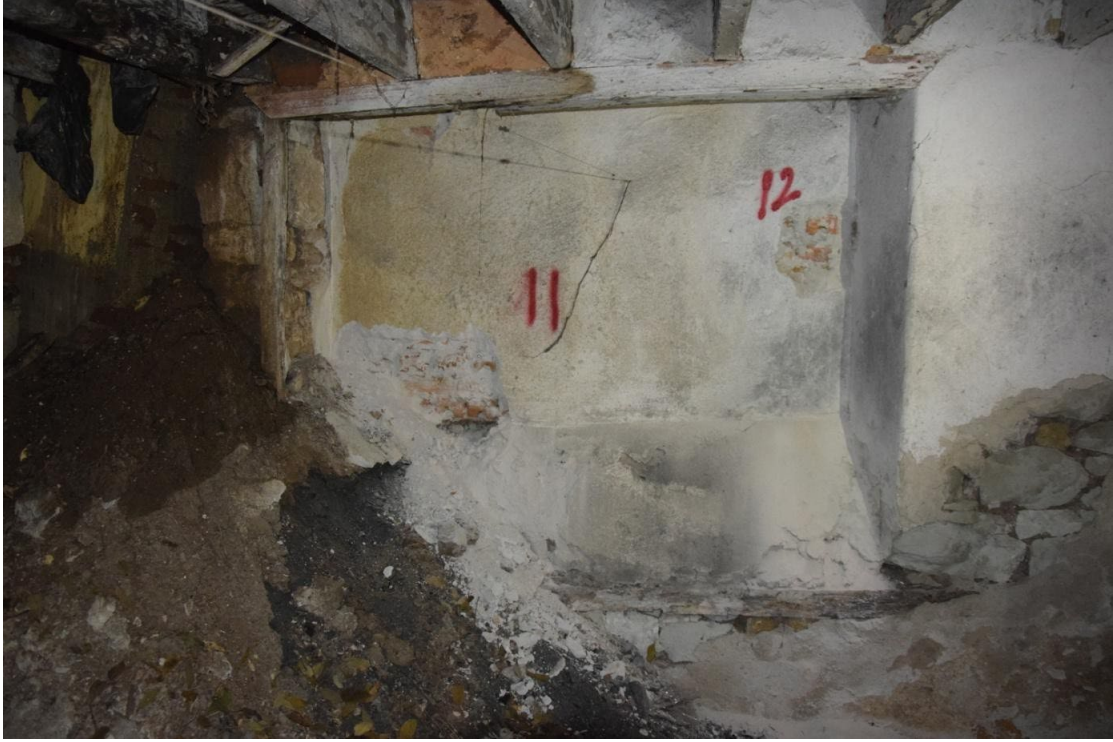
Photo 19

12 The numbered scrape was made near the right edge of the niche. It is a scrape measuring approximately 20x30 cm. No traces of a window were found here either. The bricks exposed after the cement plastering are the same as the bricks exposed in scraping number 11. (F.21)

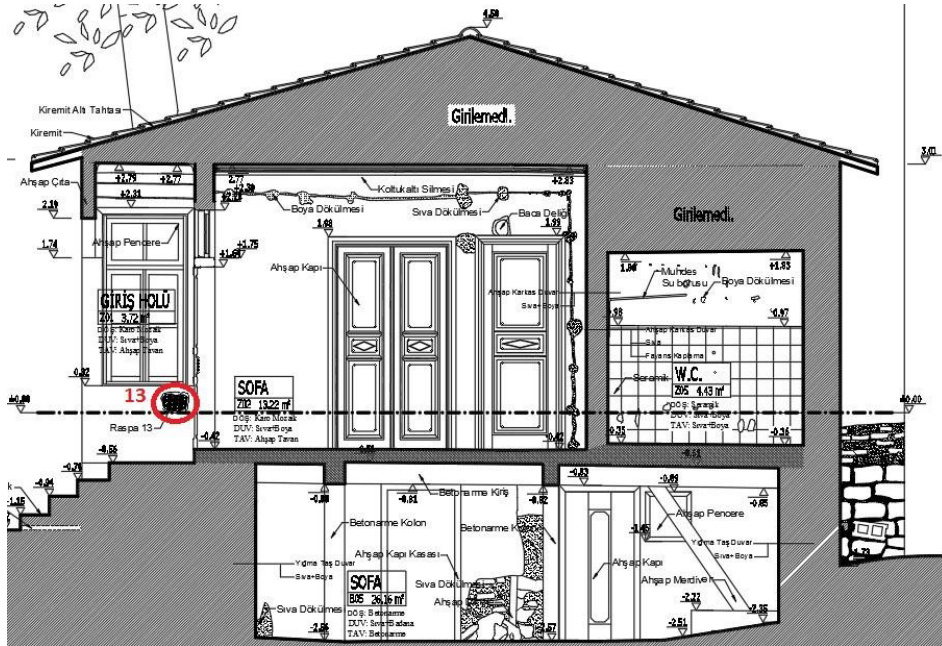
Illustration 6 - A - A'' Section

The scraping under the window to the left of the entrance hall was carried out in order to reach the traces of wooden cladding. (Drawing 6, F.22) It is a scraping measuring approximately 25x20 cm. In rasp number 13, when the cement plaster was removed, metal mesh and wood frame and filling were found. The wooden cladding could not be reached. (F.23)

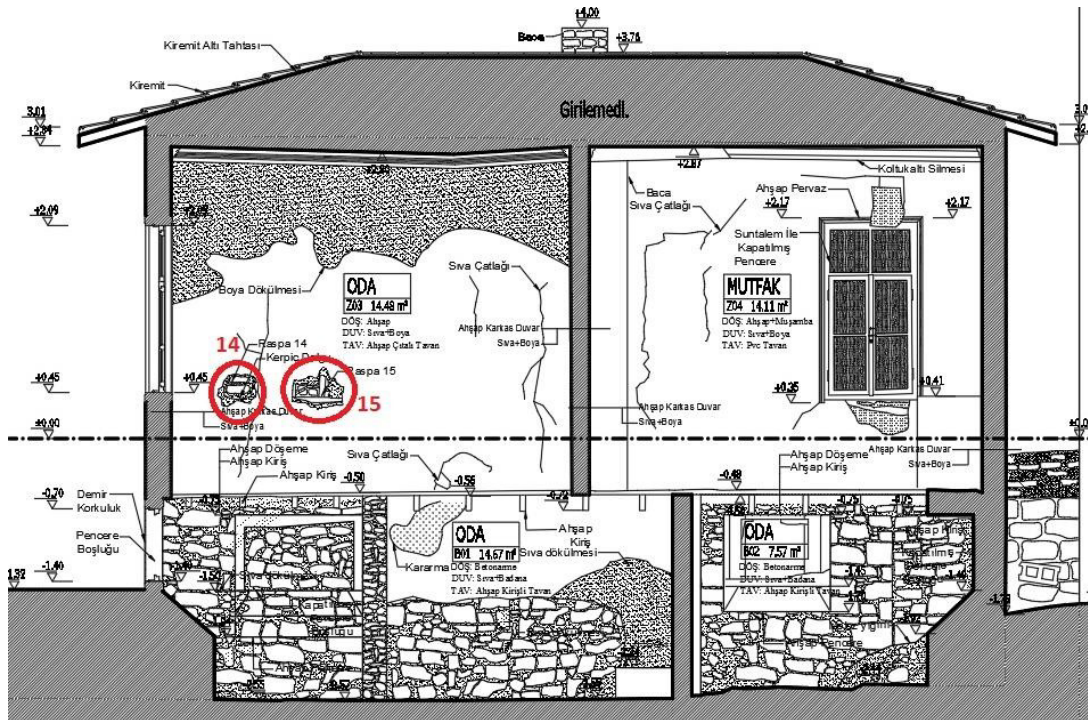
Drawing 7 - D-D Section

Rasps 14 and 15 in Room Z03 were opened in order to reach the window trace. (Drawing 7, F.24) The rasps first reached the mudbrick plaster. The presence of mudbrick plaster indicates that no intervention was made here. Nevertheless, the mudbrick plaster was partially removed. In rasp number 14, the mudbrick filling between the carcasses was reached. It is a scrape measuring approximately 30x30 cm. (F.25) In the scrape numbered 15, the wooden carcass and the mudbrick filling between it were reached. It is a scraper measuring approximately 50x30 cm. (F.26) As a result of these two scrapers, no traces of any windows were found.

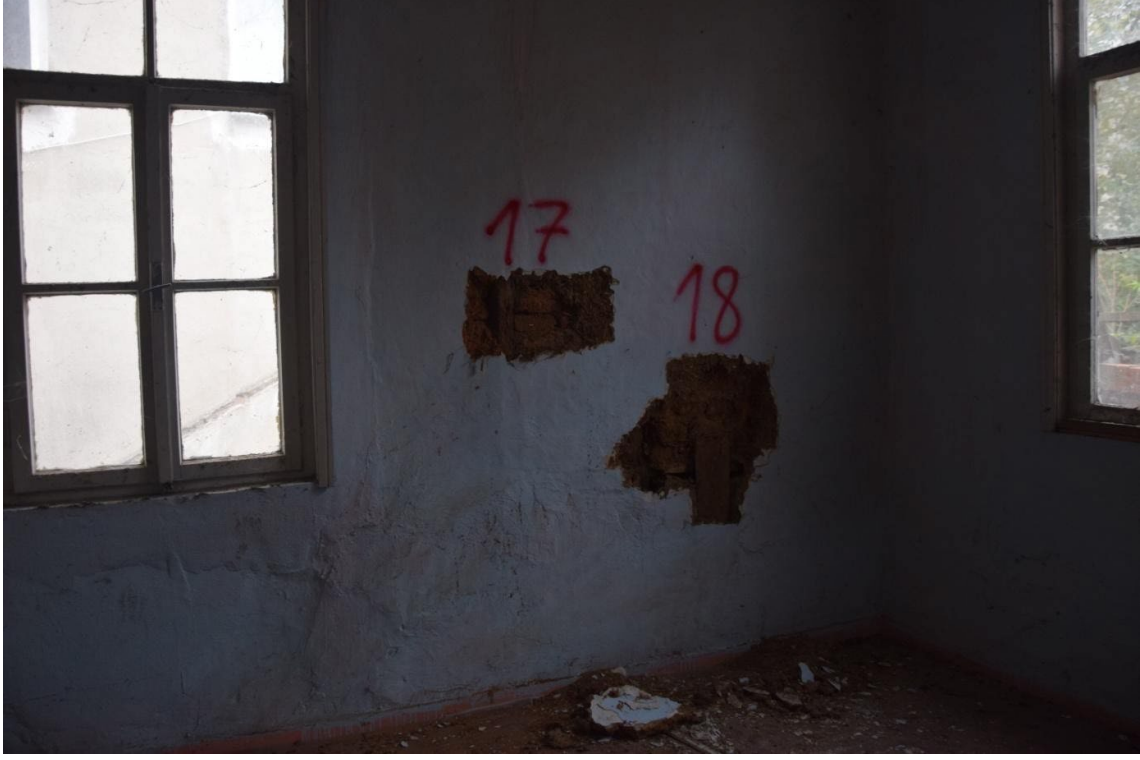
Photo 29

Rasps 17 and 18 in Room Z06 were opened in order to reach the window trace. (Drawing 8, F.29) In the rasp number 17, primarily adobe plaster was exposed. Beneath the mudbrick plaster, wooden frame and brick filling were found. It is a rasp measuring approximately 55x30 cm. (F.30) In the rasp numbered 18, mudbrick filling between mudbrick plaster and wooden carcass was encountered. It is a scraper measuring approximately 60x60 cm. (F.31) The presence of mudbrick plaster in the scrapers indicates that there is no subsequent closure here.
