## 5.RESTITUTION REPORT

The building known as the parsonage is located in the Muradiye Mosque neighborhood of Uzunköprü District, Edirne Province.

### **Building Identity Information**

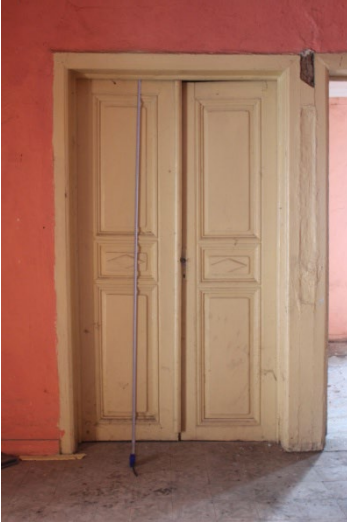
**Figure 3:**  
**Ground Floor Door**

The exterior doors and frames could not be preserved in their original form, and it was determined that they were overhauled and changed at a later date. In the restitution project, as a result of this determination, the example of the military branch located opposite the building and sharing the same garden at that time is examined and the exterior and ground floor doors and frames are changed according to this building example. The basement doors, on the other hand, were left the same since it was determined during the on-site examinations that they retained their original form.

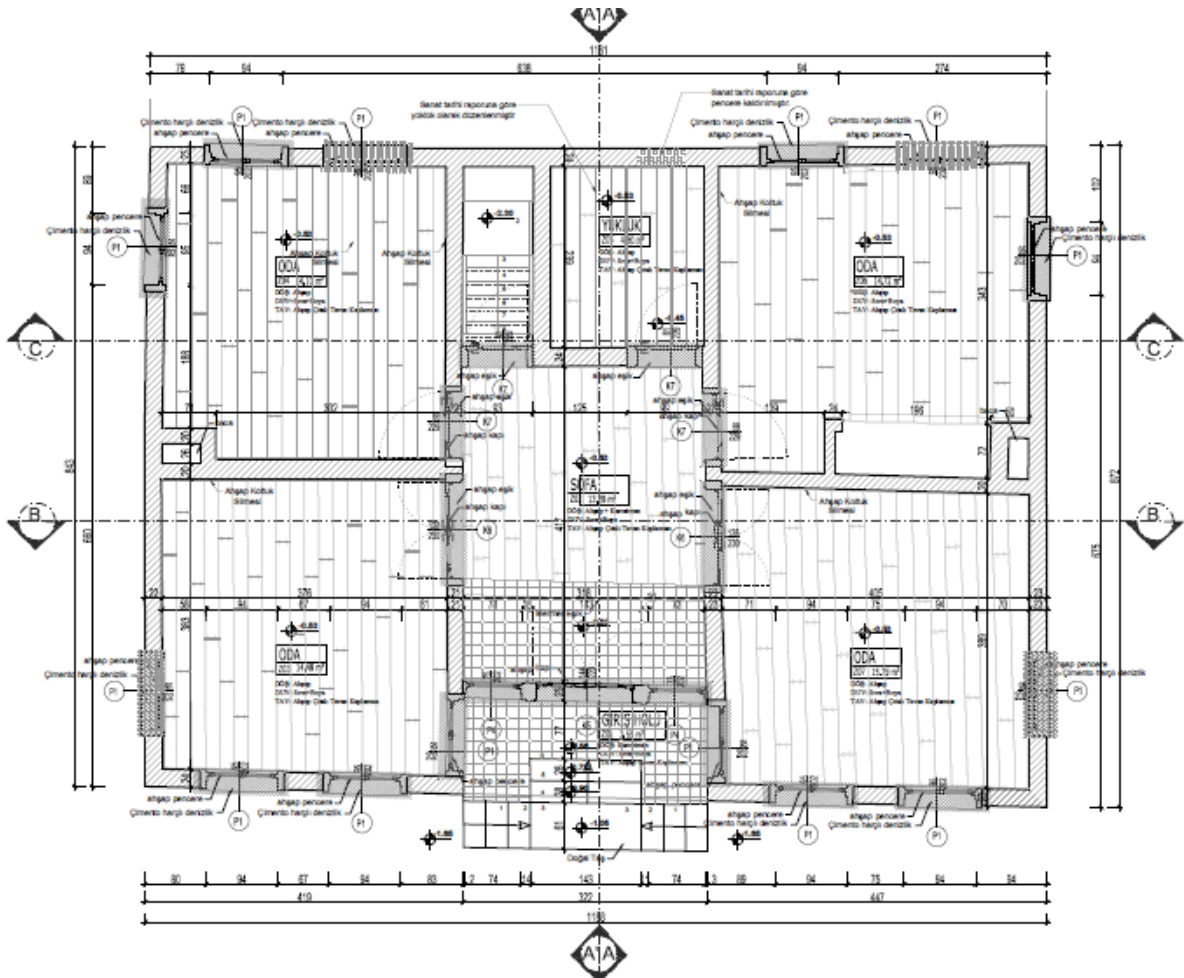
Drawing 1: +1.50 Level Plan

The plan of the building is organized in accordance with the non-Muslim residences of Thrace and is shaped around a main sofa entered through the entrance door. This sofa forms the main center of the building plan. When we examine the information about the original use of the spaces around the sofa, which forms the center of the ground floor plan, from the plans and usage schemes of the houses belonging to the same periods around Edirne and Thrace and the building, which was used as the Military Service Office for many years, we learn that the rooms entered through the doors on the right and left in the middle of the sofa, which is entered through a double-winged door, were used as guest reception and living rooms facing the street façade, and those facing the backyard were used as bedrooms. In the restitution project, the functions of the spaces were determined and named based on this information, on-site examinations and interviews with people.

It is clearly seen that significant renovations have been made within the building due to changing usage demands over time, and it is stated in the art history report that the original use of the building and naturally the plan features have changed significantly. It has also been determined during the on-site examinations that the kitchen on the ground floor in its current form and the interior spaces used as WC and bathroom have different functions in the original plan. It is also understood from the condition of the plastic pipes remaining from the existing drainage system that a significant effort has been made to ensure the harmony of the drains of the WC with the street elevation of the neighborhood where the building is located. During the interviews with the people, it was determined that there is a room in the place of the kitchen on the ground floor and a closet in the section where the WC and bathroom are located. Considering the plans and usage characteristics of the non-Muslim buildings, it was confirmed that the kitchen and WC on the ground floor were not present in the original plan, and it was understood that there were rooms and cargo holders according to the size of the spaces. The art history report also states that in the original plan of the building, the WC was located in the basement or in the garden, the kitchen was located in the basement as the original use of the building, and there were rooms and cargo holders on the ground floor. Taking this into account while preparing the restitution project, the room named B02 next to the staircase on the basement floor was organized as a kitchen, the room named B04 as a WC, the place of the WC on the current ground floor as a cargo (Z05), and the place of the kitchen as a room (Z04).

The closet arrangement built against the wall in the right side of the existing ground floor rooms according to the entrance is also suitable for bedrooms. The current use of the room on the left side as a kitchen shows that this section was created with later renovations. Because it is obvious that the wooden floor in the original structure is not suitable for such a

kitchen. Considering the other contemporary examples of the building, it is stated in the art history report that this kitchen organization should also be located in the basement and even the kitchen section should be located in the back left corner of the basement facing the rear facade of the basement, which has a window closed today, right next to the staircase descending from the ground floor to the basement, and examples supporting this situation are found in many contemporary buildings around Edirne. At this point, another architectural element indicating that the existing kitchen was a room is the location of the chimney organization. The chimney, which was built in accordance with the layout of non-Muslim buildings heated with stoves, is located on the outer corner of the wall adjacent to the room on the street side of this section and was built to meet the chimney needs of both rooms. The chimney within the existing kitchen section, which was built as a ventilation shaft for the kitchen, was realized to have been built later. Another chimney arrangement within the building, the position of the chimney in the bedroom where it is located, also supports the fact that the kitchen section was originally built as another room. This chimney was placed between the walls of the bedroom and the guest reception or living room at the front and included in the plan to meet the chimney needs of both interior spaces.

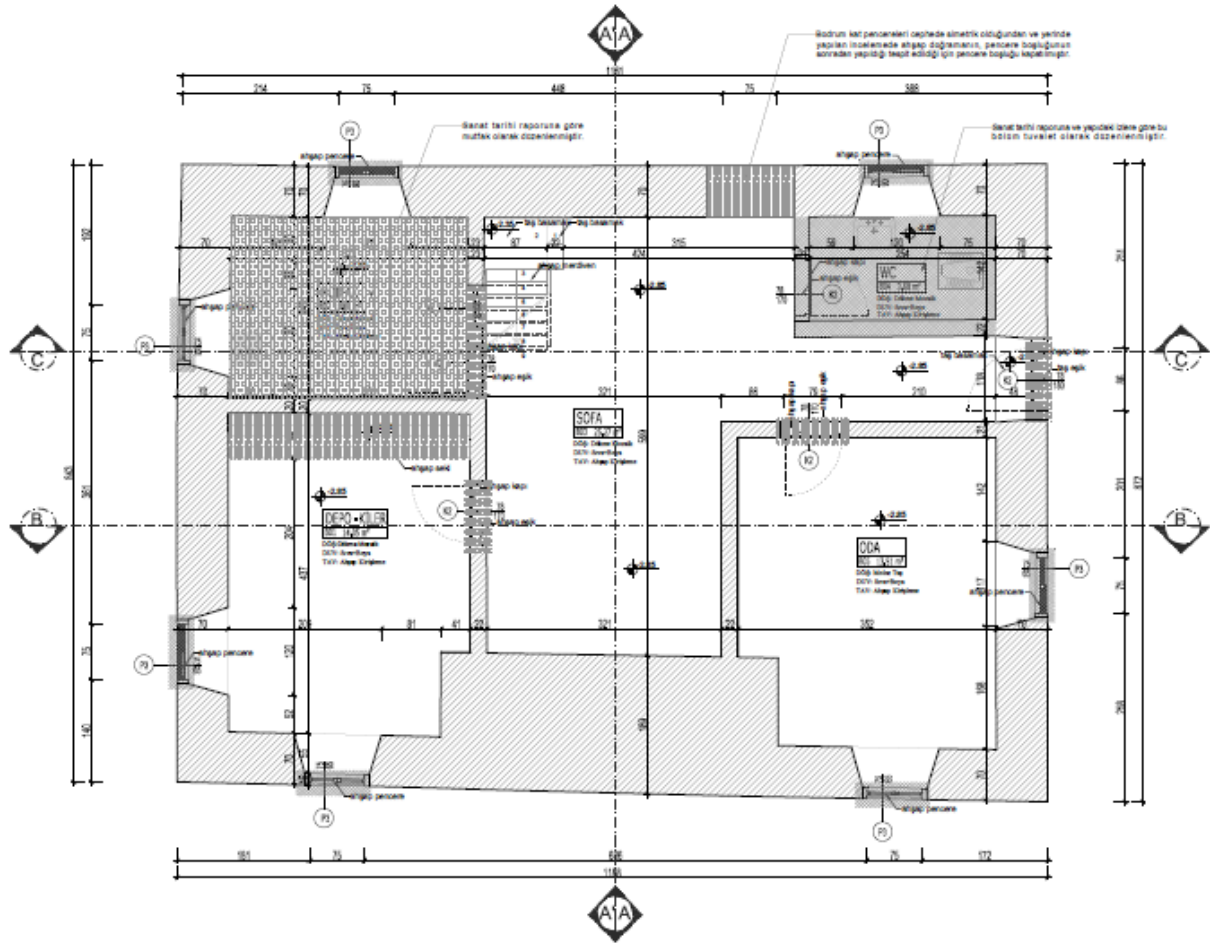
Drawing 2: -1.00 Level Plan

The plan of the basement floor is organized around a central sofa in accordance with the ground floor. It is seen that some of the windows in the basement were closed during the renovations, and these closed windows provide important information about the original use of the building. In general terms, the one next to the staircase among the sections that make up the basement floor should actually be the original kitchen space. The fact that this section has a service window next to the entrance door, which is clearly related to the staircase, supports this situation. It is also noticed that this section has two windows, one of which is still open and the other one is covered. It was determined in the art history report and as a result of the on-site investigations that this room was actually a kitchen.

Adjacent to the room designated as the kitchen, the large rectangular section on the street side, which is entered through a door opening from the room that forms the center of the basement plan, is likely to be a wine storage or cellar. The fact that this section originally received limited light and plenty of air from two small windows, one facing the street and the other facing the side garden, shows that the purpose of keeping this section cool was a priority. In addition, the traces of a bench-like arrangement on the wall on the kitchen side of this section also constitute evidence for the use of this space for winery and storage purposes. The fact that the basement is only connected to this room also indicates that this section was actually used as a storage room or cellar, which was determined during the on-site investigations and stated in the art history report. In the restitution project, the windows that should have been preserved and the windows that were closed in the existing structure were drawn in accordance with the original.

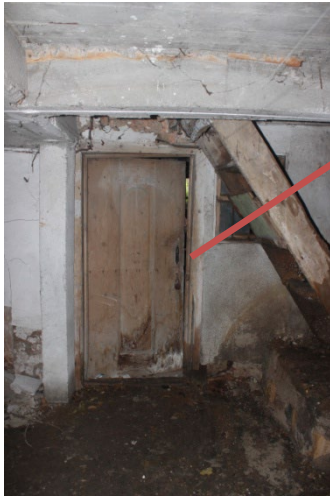
**Image 7**

It was determined that there is a kitchen in the restitution project.

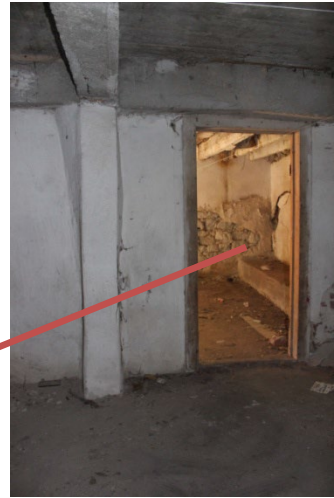
**Picture 8**

It was determined that there is a cellar in the restitution project.

The room on the other side of this room has no connection with the central sofa arrangement, and the entrance to this section is provided by a door opening to a short corridor arrangement that opposes the kitchen door and leads to an exterior door opening to the outside. It is possible that this room, which is connected to a small door opening to the outside, was a servant's room. The fact that it has two windows, one facing the facade and the other facing the garden, is also stated in the art history report that it was planned as a living space. In the restitution project, it was left the same as it preserves its originality.

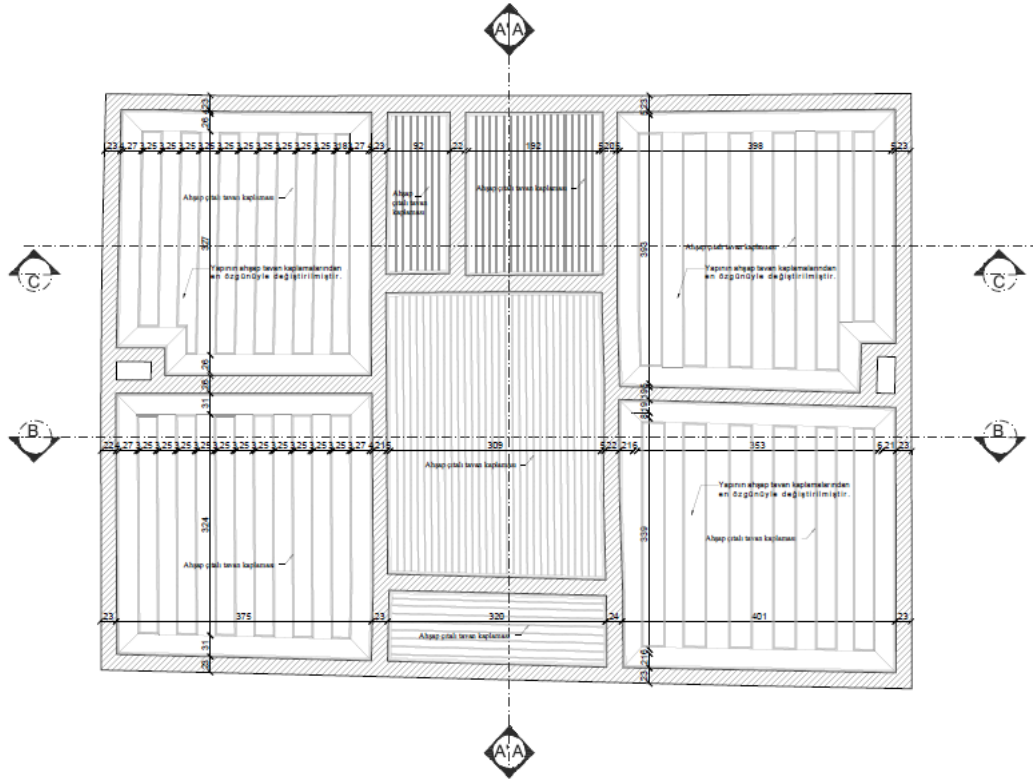
**Drawing 3: Ceiling Plan at Level +1.50**

It has been determined by on-site examinations that the room ceilings have largely preserved their original identity. When the restitution project was drawn, the ceilings of the rooms on the ground floor plan were drawn according to the ceiling of the room on the left side of the entrance, which is the most appropriate to its essence. The ceilings of the part of the sofa, loadroom and staircase outside the rooms were arranged as the ceiling covering of the existing sofa.

One of the most important features showing the renovations in the building is that the wooden floor of the ground floor has been converted into reinforced concrete on the floors of the WC and bathroom sections and the hall. It is stated in the art history report that it is not possible to find this reinforced concrete formation in the original building. The presence of reinforced concrete carriers next to the existing wooden carriers in the basement floor proves this situation. While preparing the restitution project, the reinforced concrete

carriers and beams were removed and the basement floor ceiling covering was arranged by maintaining the existing wooden carriers.

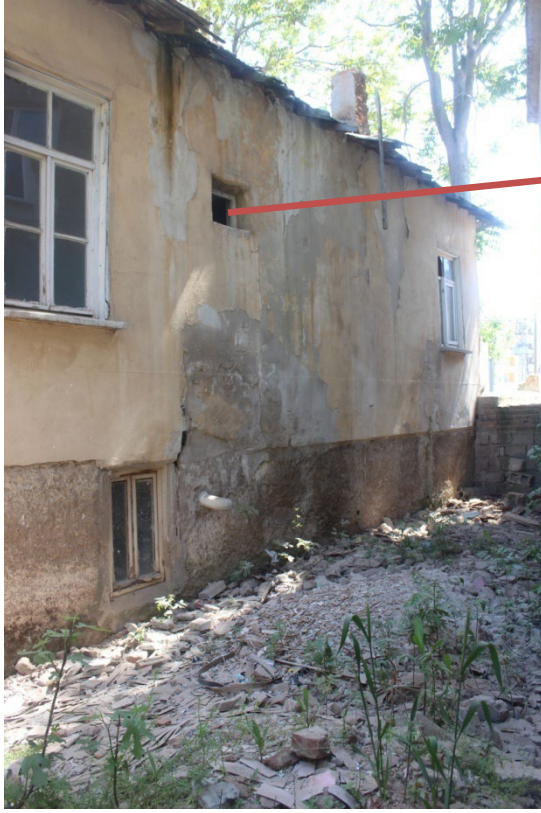
**Image 11**

It was removed from the rear façade of the restitution project. It has been determined that it looks incompatible on the facade and was originally dysfunctional.

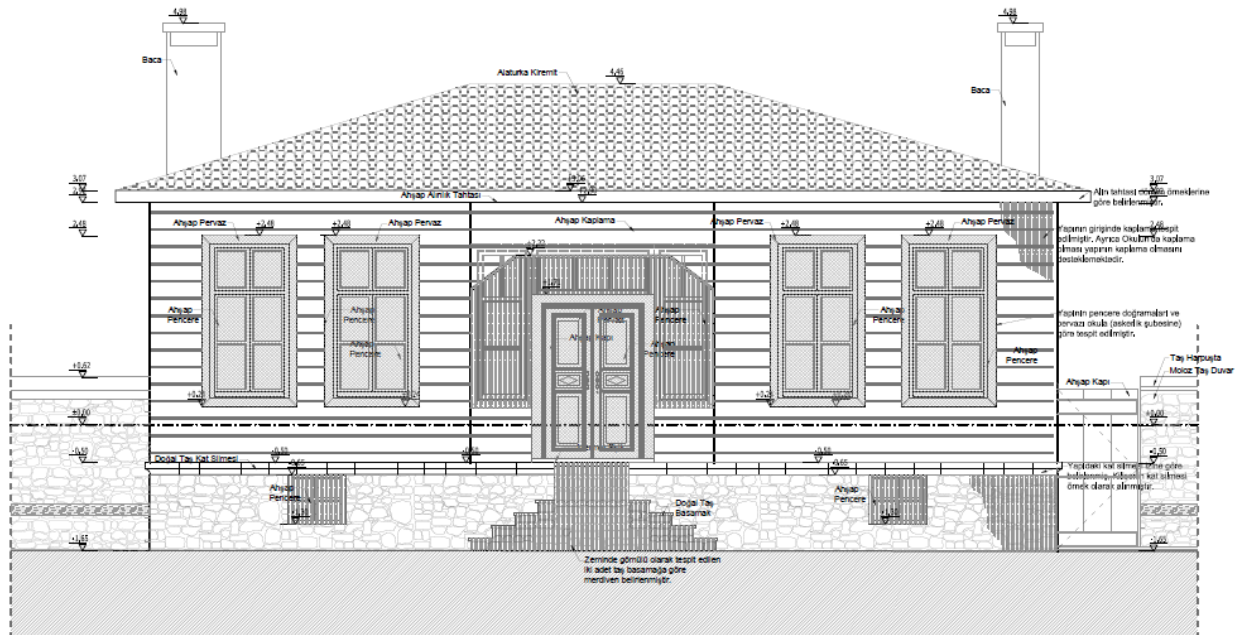
### Illustration10: Front Facade

It was determined from the traces on the walls that both rooms facing the street on the right and left of the central hall have two windows each, as well as one more window facing the garden on the side, during the on-site examination of the building. Apart from these two rooms, it is clear that the one on the right side of the rooms facing the rear facade was used as a bedroom, as can be understood from its current shape. Similar to the front rooms, it was noticed from the traces on the wall that these rooms also have two windows on the facade facing the backyard and one window opening to the side garden, and it was stated in the art history report and the facades in the restitution project were drawn accordingly.
